INVESTIGATION REPORT FOR COON CREEK WATERSHED STRUCTURES 21, 23, AND 29,
AND WEST FORK KICKAPOO WATERSHED STRUCTURES MLSNA AND 1
MONROE AND VERNON COUNTIES, WISCONSIN

U.S. DEPARTMENT OF AGRICULTURE
NATURAL RESOURCES CONSERVATION SERVICE

June 26, 2019

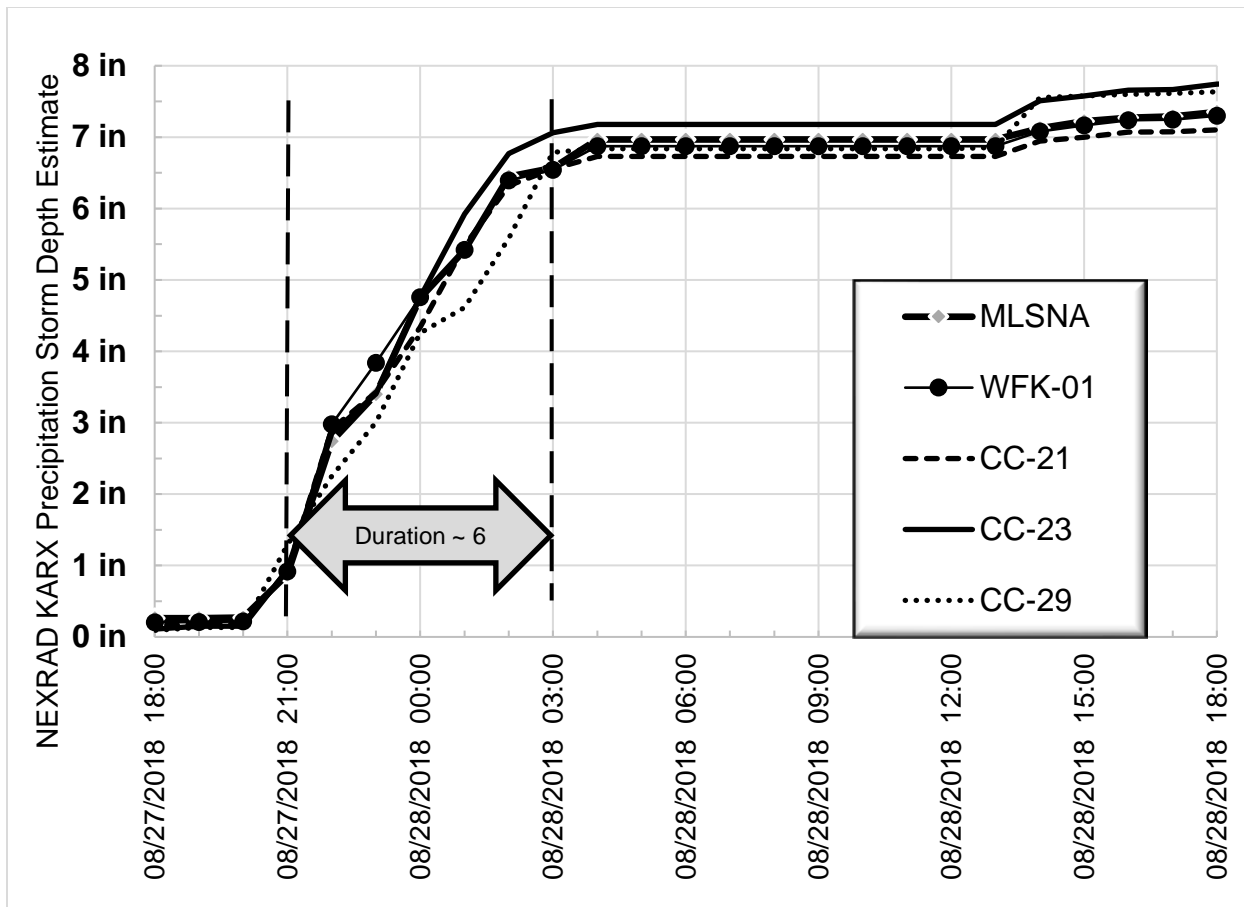
Figure 1 Storm Rainfall from NEXRAD Data KARX-LaCrosse, WI

Figure 1 shows the radar precipitation estimate from NEXRAD radar station KARX in LaCrosse, WI for the 24-hour period August 27 18:00 through August 28 18:00, which is the time period of the rainfall causing the five breaches. The storm duration is approximately 6 or 7 hours. Additional precipitation estimates from various sources can be found in the Detailed Hydrology Report as an attachment.

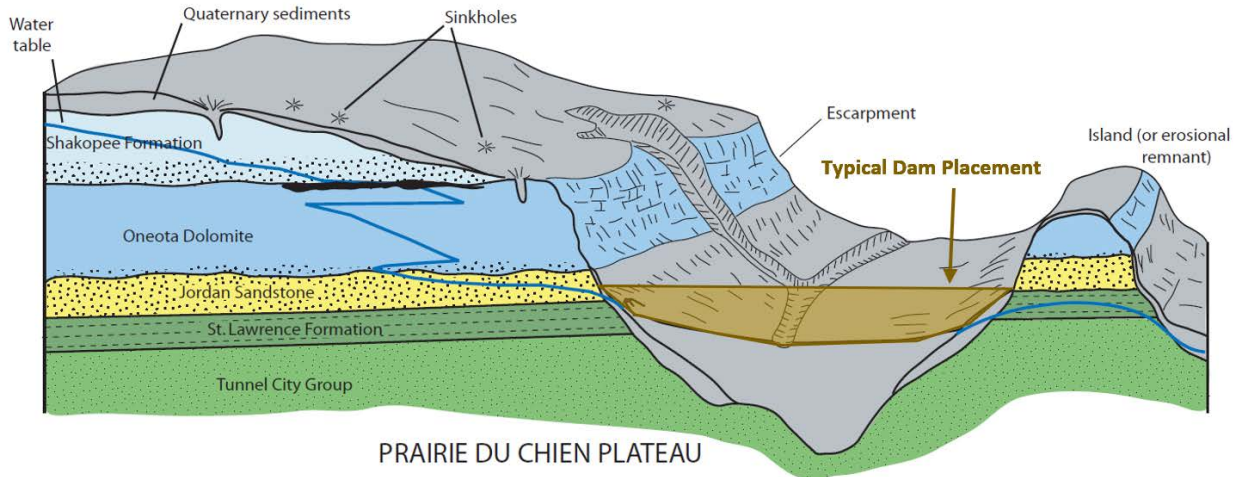
Figure 2- Block Diagram showing the general geologic setting of the Prairie Du Chien Plateau and the PL-566 structures breached in the August 2018 flood event. The typical dam placement is shown in brown. Note that this is just for illustrative purposes. The dam could be slightly higher or lower depending on how high up the valley it is. Also note that even without the dams in place the regional water table naturally discharges out of the hill at the intersection of the St. Lawrence (on top of Black Earth Member aquiclude) and the Jordan formation and discharges into the colluvium and into the alluvium below the dams.

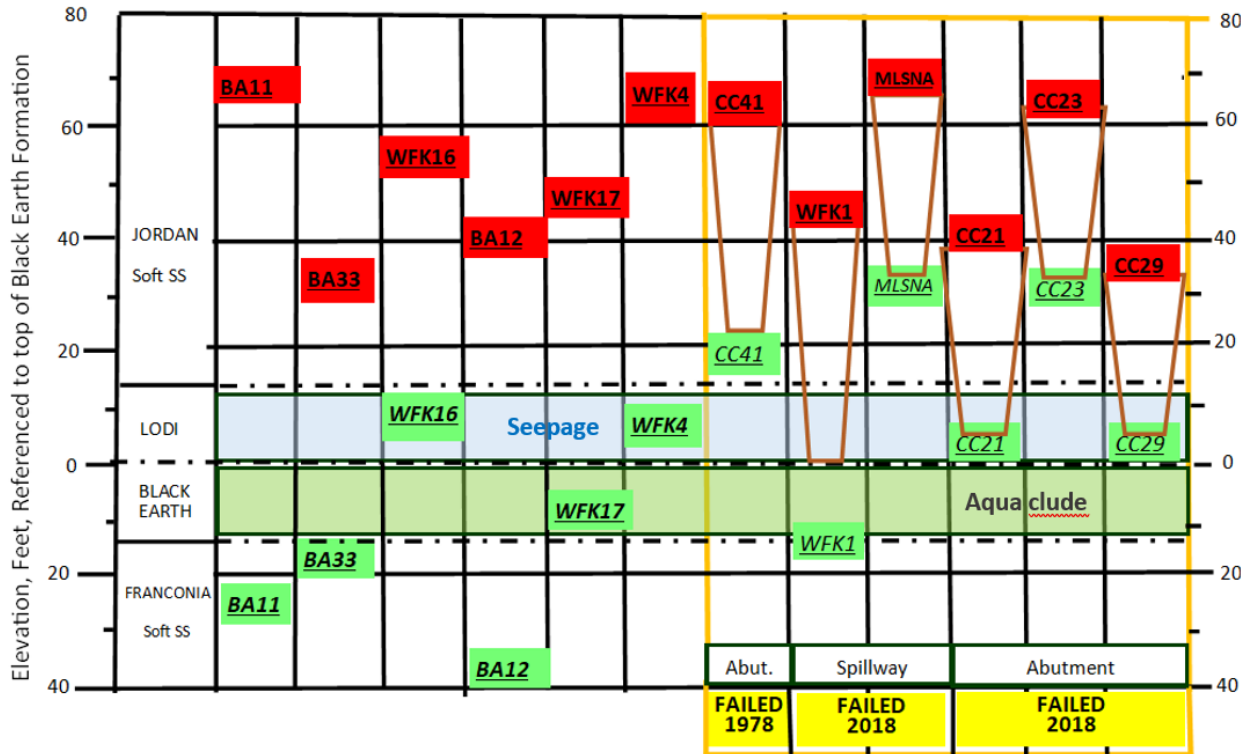
Material Strength, Permeability, and Regional Groundwater Flow are important geologic conditions that likely caused adverse effects at the dams. As shown in Figure 4, all five PL-566 structures that have breached in Wisconsin were either in the soft, weakly cemented Jordan Sandstone or the high permeability Lodi Member of the St. Lawrence formation. Experience in this area shows that the Jordan Sandstone weathers to a loose highly permeable non-plastic sand (SM or SP). The previously mentioned materials were expected to be present in the breached zone based on observations on site and as-built interpretations summarized on the drawings in Attachment E.

Figure 4- Effective Stratigraphy of selected PL-566 dams in WI. Top of dam elevation shown in red and bottom of core trench elevation shown in green. Brown polygons have been drawn to show the relative elevation of breaches.

As shown in Figures 2 & 4, the Black Earth Member of the St. Lawrence formation is a known Regional Aquiclude. This means that whether the dams were built in those locations or not, the local water table would have already been elevated. And so there was a high likelihood of water seepage and springs already occurring at that stratigraphic position.

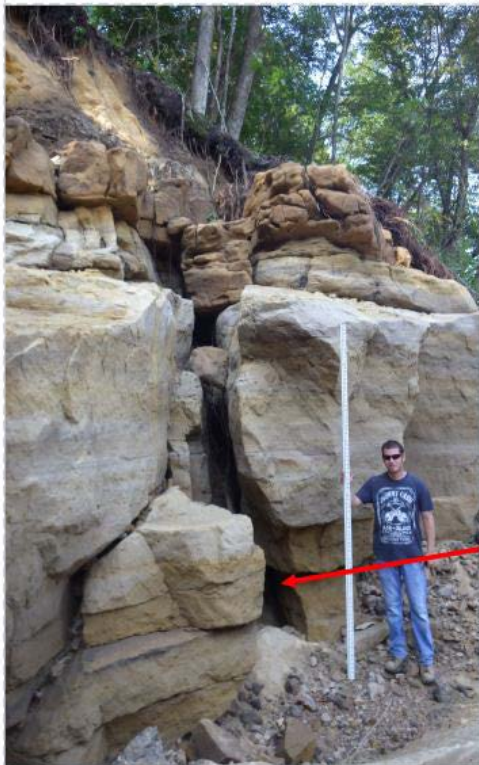
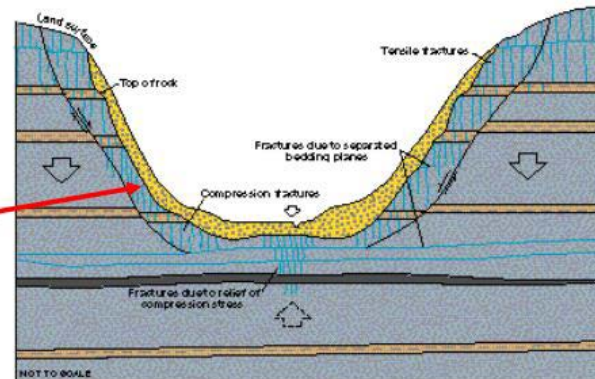
Valley Relief Fractures in the CC-23 2018 Abutment failure

Figure 92. Stress relief occurs when compressional stress is partly removed by erosion of overlying rocks; this results in the formation of predictable fracture patterns in valleys. The fractures are generally horizontal under valley floors and vertical along valley walls. The interconnected fracture system greatly increases the permeability of the rocks, especially in the valleys.

Figure 5 provides an explanation of how valley stress relief fractures form, including a photo of an interpreted valley relief fracture in the wall of the CC-23 abutment. These fractures run parallel to the valley flow direction which make them a likely bypass for the structure.

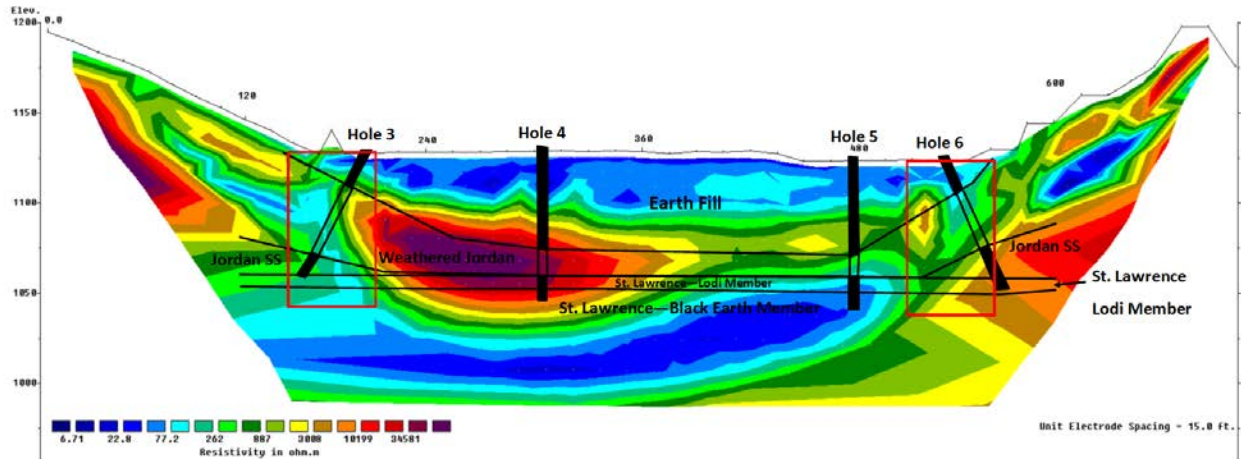
CC-33 ERI Line 1 DIP-DIP—48 electrode—15 foot spacing.

Figure 6 illustrates an Electrical Resistivity Imaging (ERI) line and rock borings of a PL-566 site with highly weathered fracture zones on the two abutments. These were identified based on the presence of particularly soft and weathered sandstone in locations of low resistivity anomalies (red boxes). The low resistivity may indicate that water is moving through the fracture.

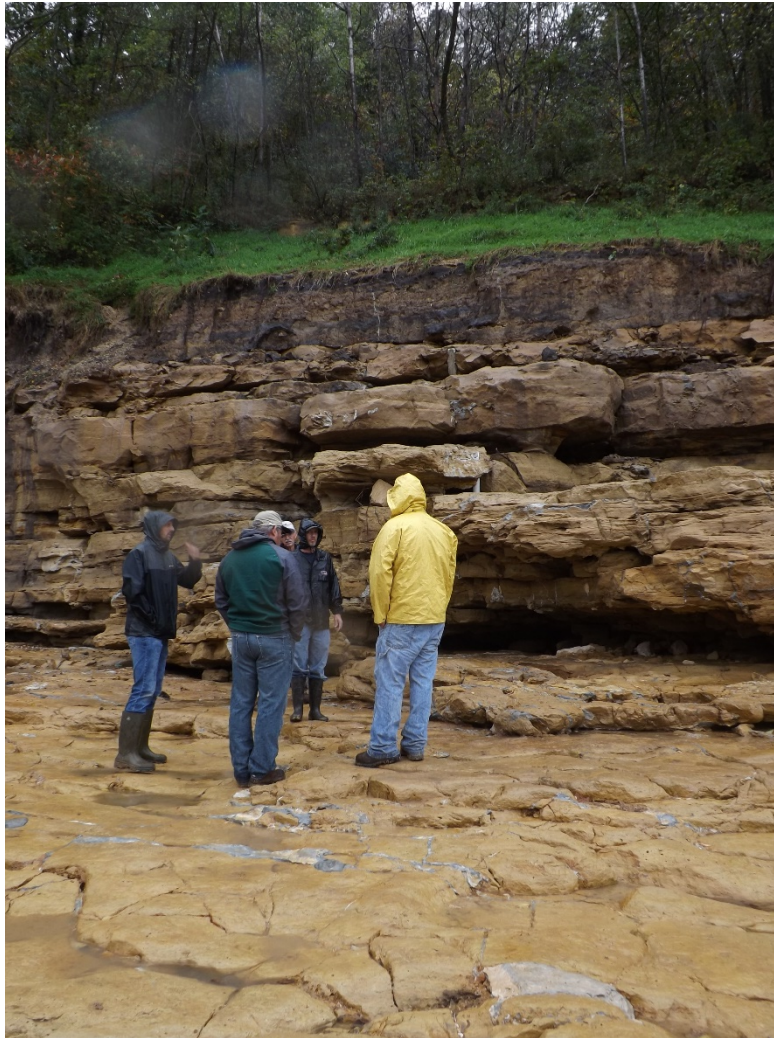
Photo 4

Close up of exposed right abutment near centerline of dam. Grouted fractures in the breach channel bottom and large voids of eroded sandstone in the abutment face.
(WFK 1)

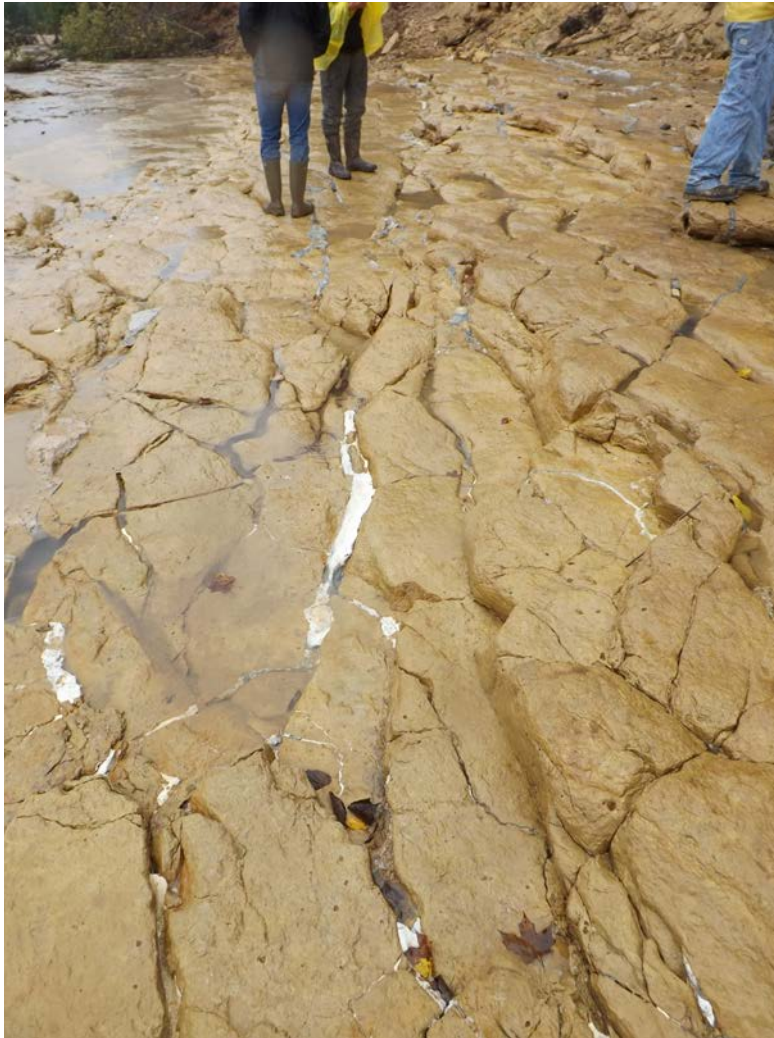
Photo 5

Vertical fractures in exposed bedrock. Note white and gray material is from 2009/2010 pressure grouting.
(WFK 1)

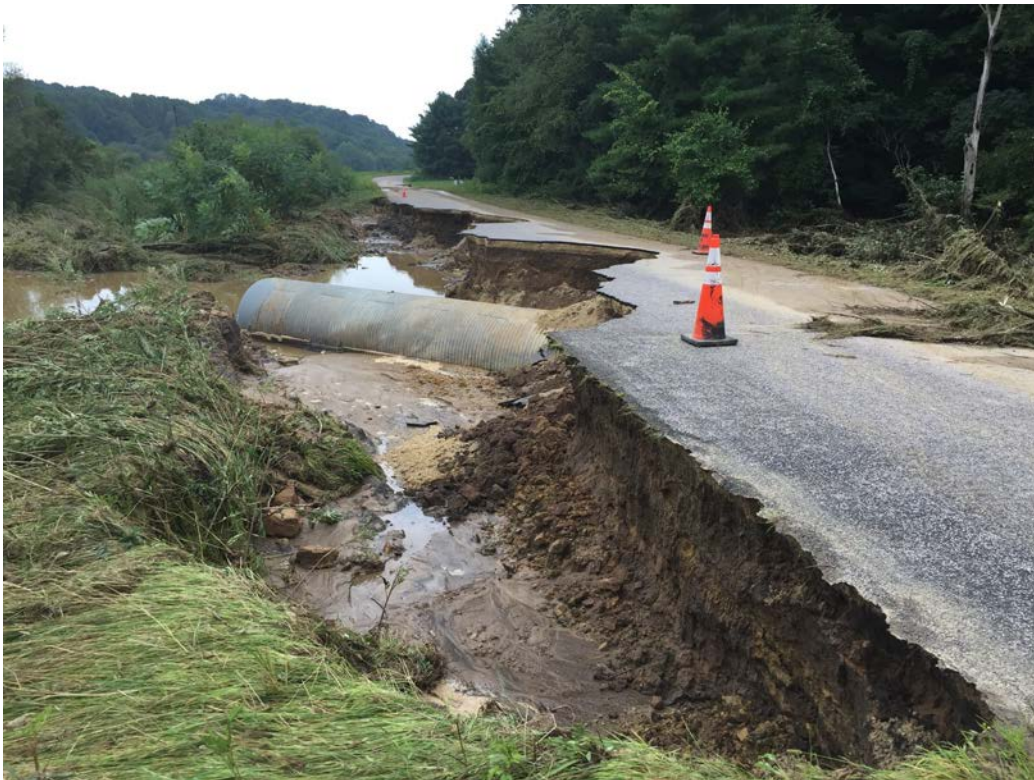
Photo 25
Damaged road in breach inundation area.
(WFK MLSNA)

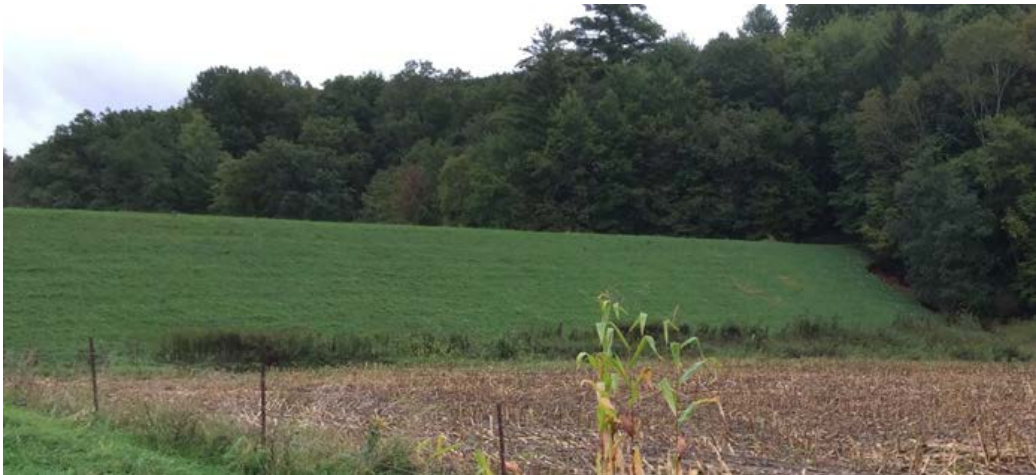
No damage to the downstream side of the embankment was observed. The vegetative cover appeared to be intact showing no sign that vegetative shear stress was exceeded (see Attachment B, Photo 29). The groin on the left end of the embankment, however, was damaged significantly (see Attachment B, Photos 31, 32 and 33). A fence had been constructed down the groin and there is a defined change in vegetative cover with grass on the dam side and timber on the opposite side of the fence. The vegetation evidently failed on the timber side first, on the lower slope of the groin, and then migrated upstream crossing under the fence and onto the dam side of the groin. The as-built plans show that sod was placed in all the groins with a channel shape similar to a parabola (see Attachment C, WFK 3 Sheet 18 of 18). While the right groin has been maintained, the left groin has not. The fence and encroachment of the timber have changed the flow characteristics and erosion resistance of the left groin. This observation holds significant implications for the stability of the vegetation in the groins of all the dams in this area.

Photo 29
Downstream side of embankment. Vegetative cover did not fail during over-topping.
(WFK 3)

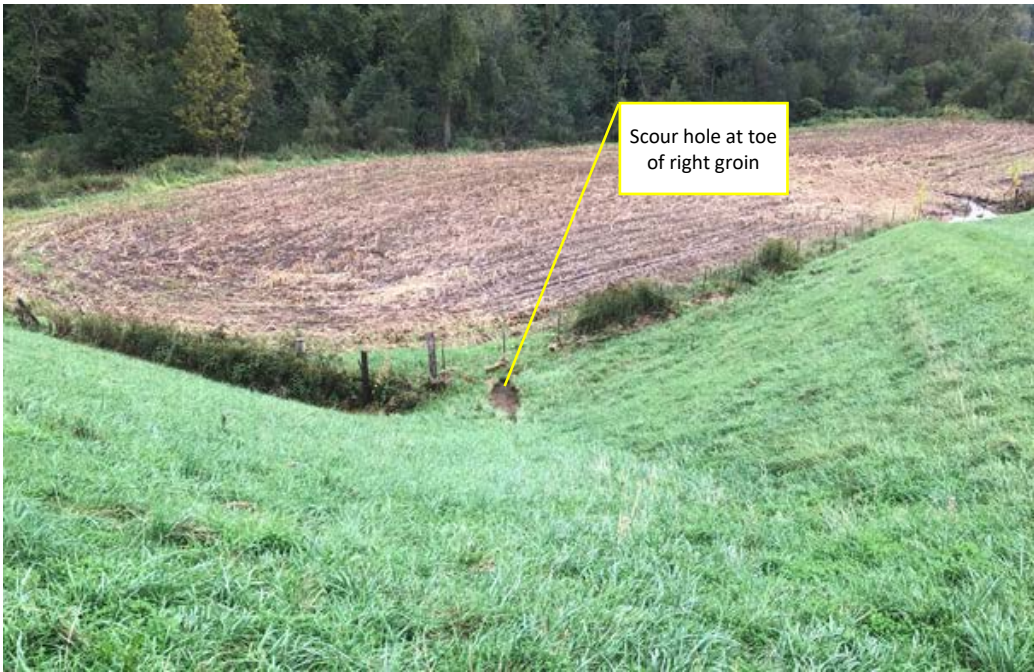
The committee then traveled to WFK 3. While this site was not part of the investigation, it was an opportunity for the committee to see a site that overtopped without breaching. Except for a shallow scour hole at the very end of the auxiliary spillway (see Attachment B, Photo 26 and Photo 27), there was remarkably little damage (see Attachment B, Photo 28). Note that a field fence had been constructed immediately downstream of the end of the auxiliary spillway and that there was a defined drop in elevation from the auxiliary spillway side to the field side of the fence (see Attachment B, Photo 27). This sharp change in gradient appears be the impetus for developing the scour hole. A much smaller area of scour was noted at the downstream toe of the right groin; a function of the overtopping flow (see Attachment B, Photo 30).

Scour hole at toe
of right groin

Photo 30
View of right groin from top of dam.
(WFK 3)

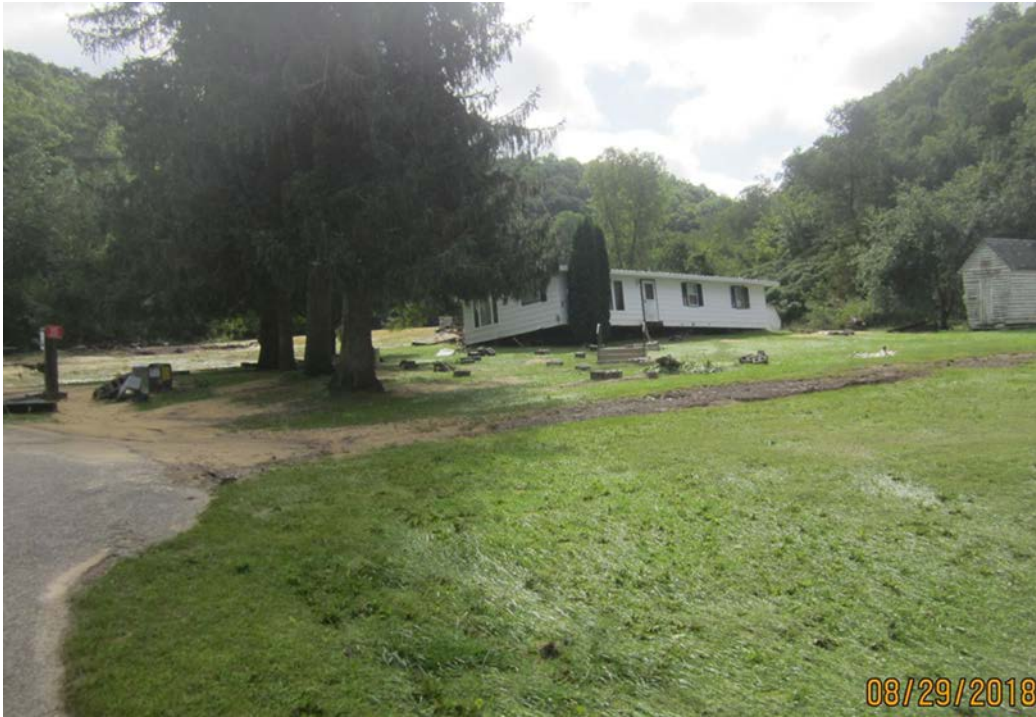
Photo 58
View from downstream county road of damaged house in breach inundation area.
(CC 23)

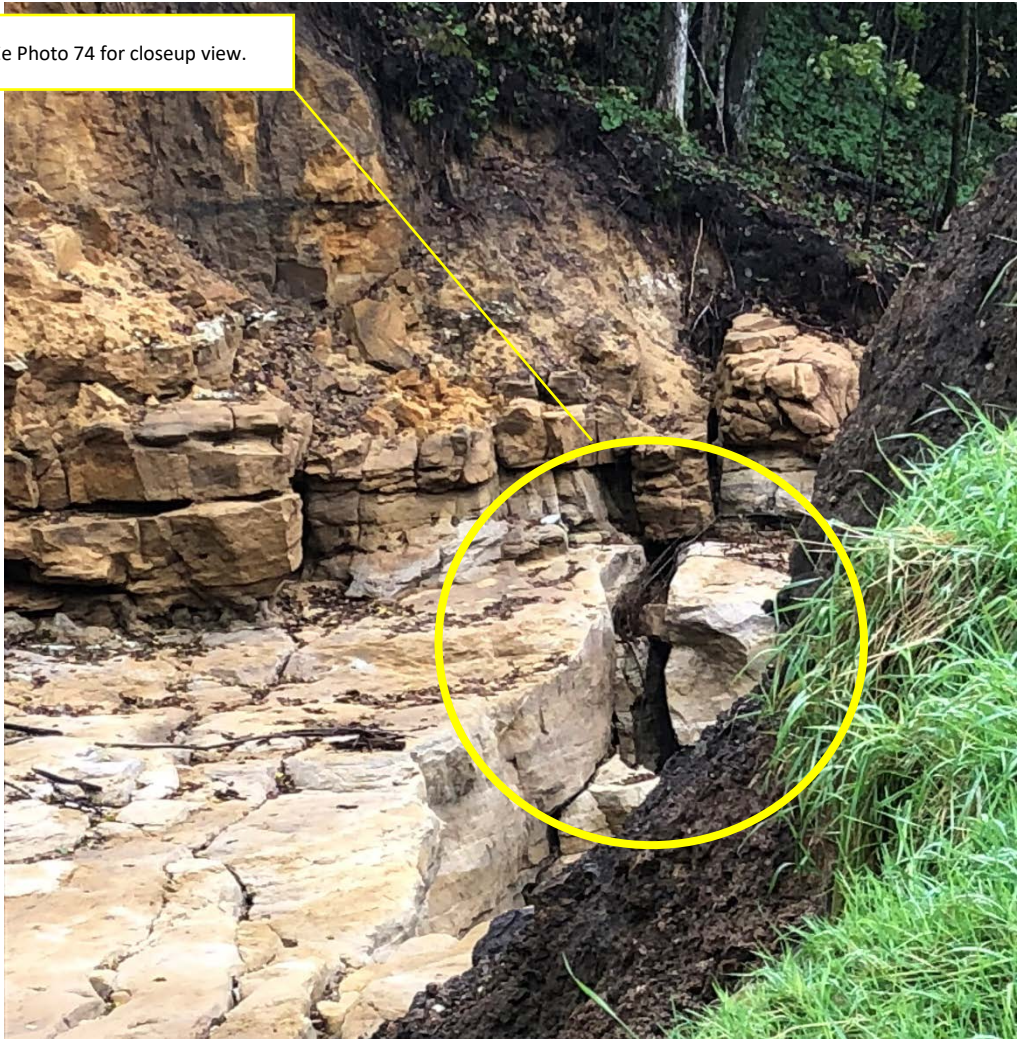
Photo 73

View of vertical valley relief fractures in exposed bedrock of breach channel.
(CC 23)

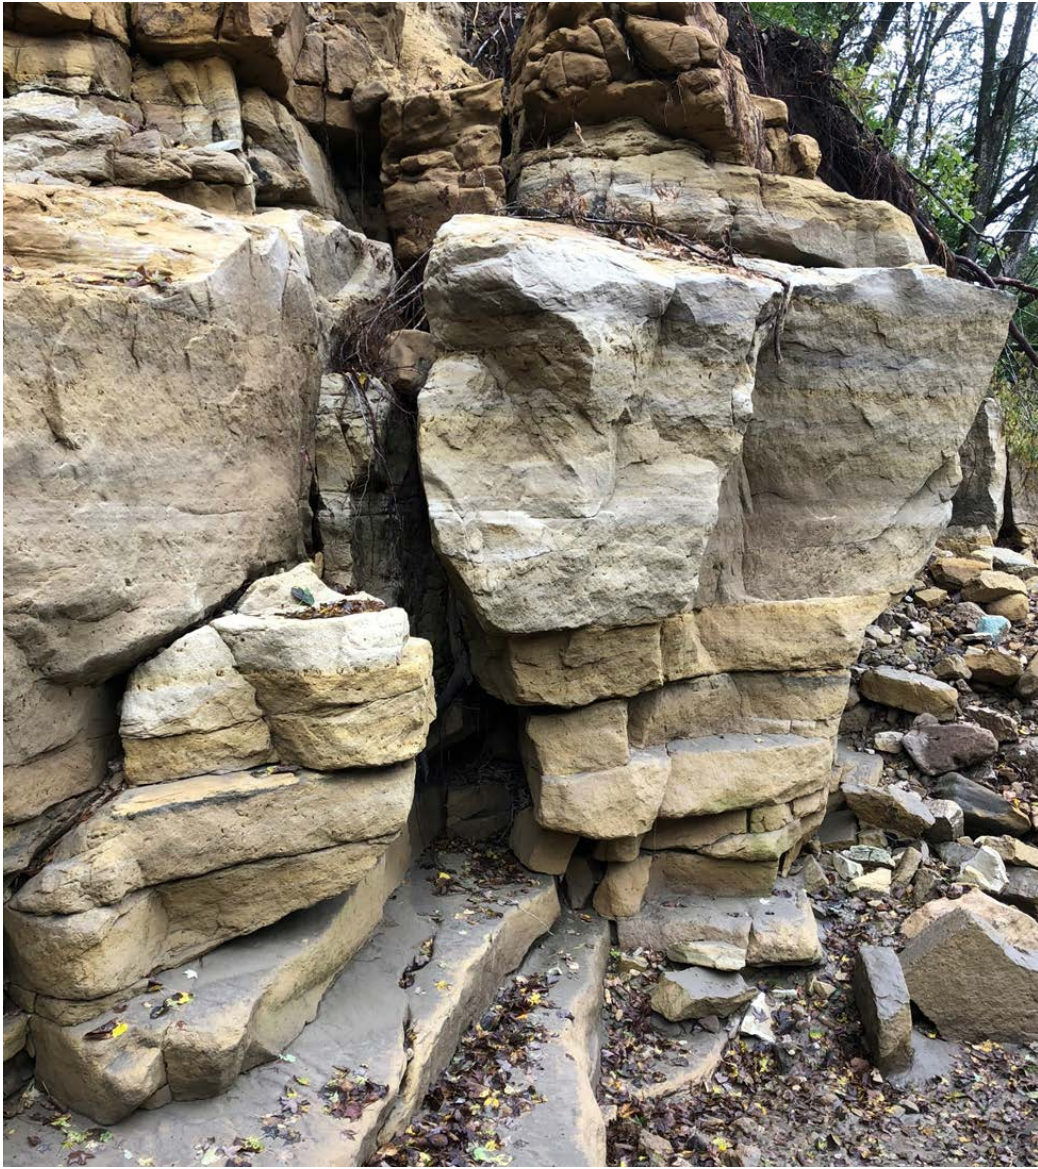
Photo 74
Close up view of vertical valley relief fracture.
(CC 23)

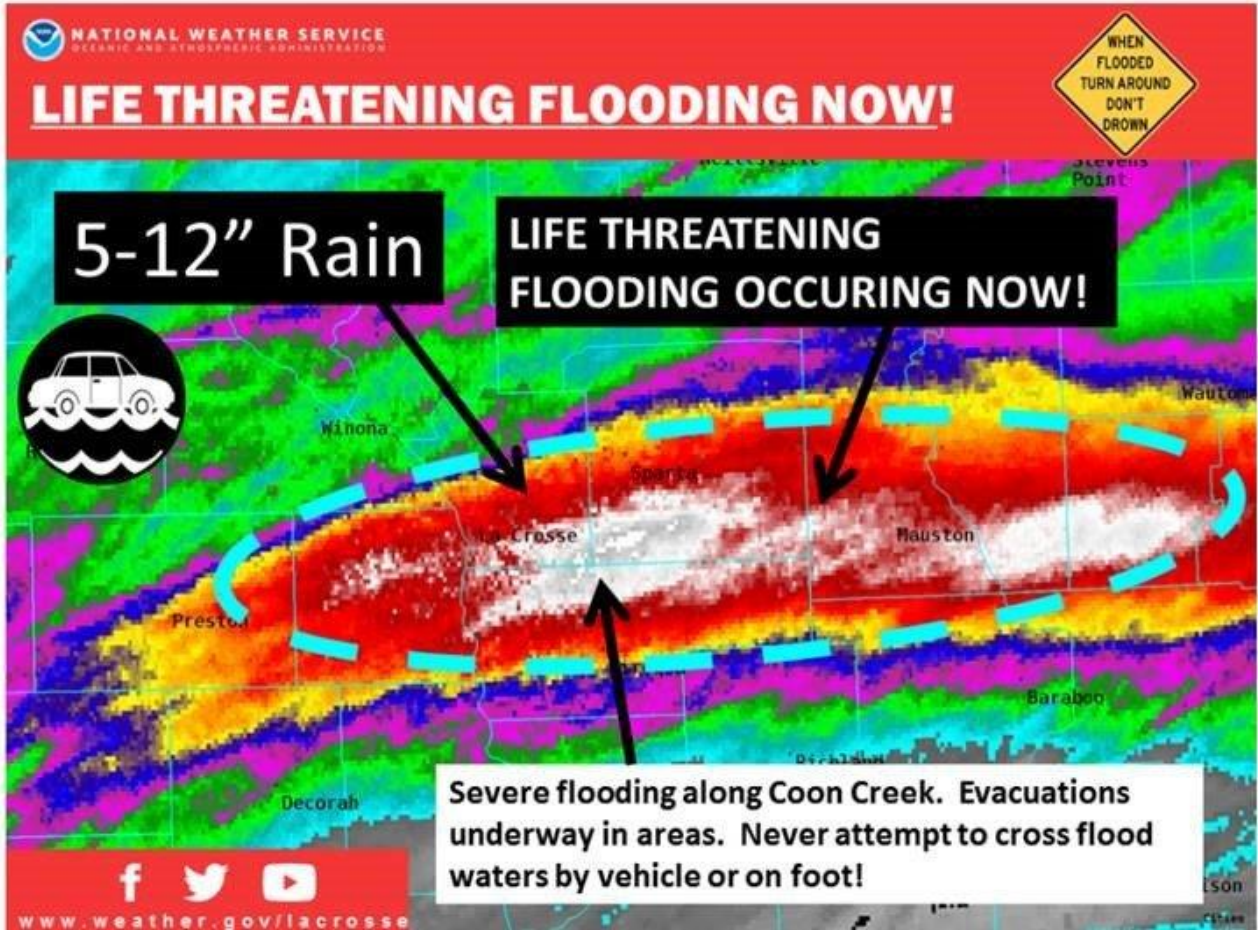
Figure 2 NWS Rainfall Graphic warning of Coon Creek flooding (Rainfall duration unspecified) Published Tues Aug 28th

NWS radar loops show the timing of the storm, as shown in Figure 2 **Error! Reference source not found.** The significant rain started around 8 pm Monday, August 27th and ended by 4 am Tuesday, August 28th. The NWS warned of flooding along Coon Creek with estimated rainfall of 5 to 12 inches.
