INVESTIGATION REPORT FOR COON CREEK WATERSHED STRUCTURES 21, 23, AND 29,
AND WEST FORK KICKAPOO WATERSHED STRUCTURES MLSNA AND 1
MONROE AND VERNON COUNTIES, WISCONSIN

U.S. DEPARTMENT OF AGRICULTURE
NATURAL RESOURCES CONSERVATION SERVICE

June 26, 2019

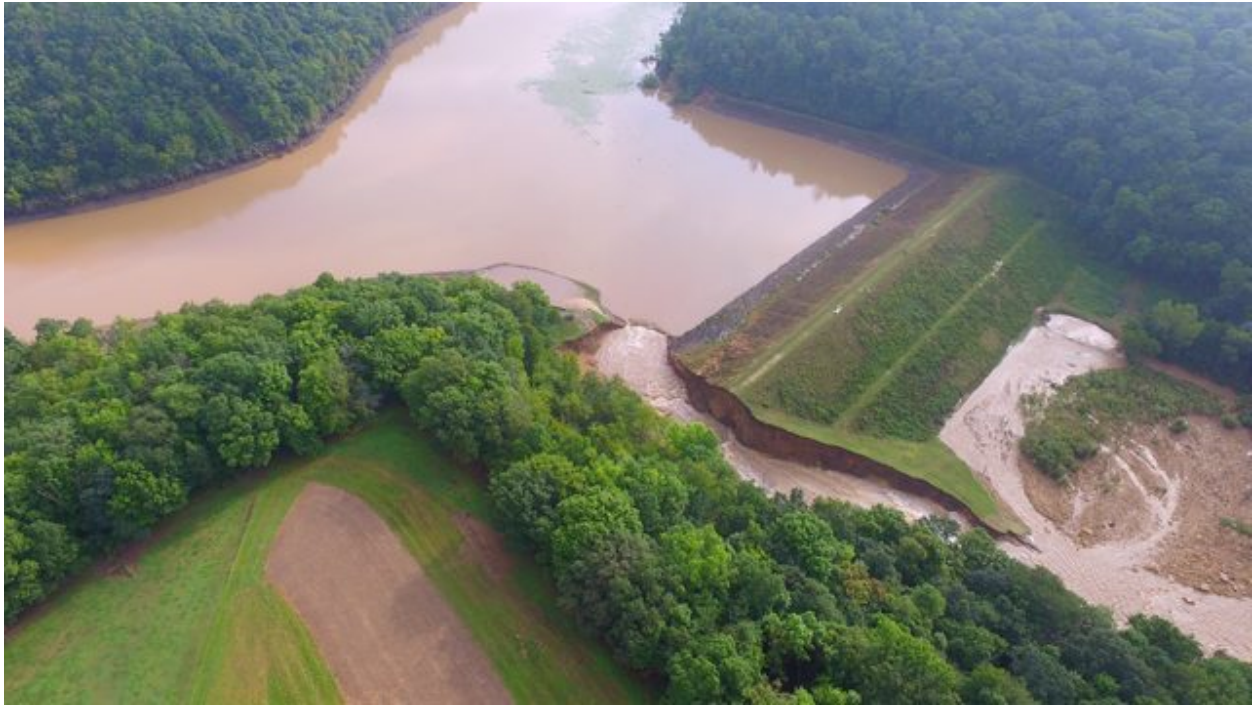
Photo A1
Aerial View of WFK 1 following breach on August 28, 2018

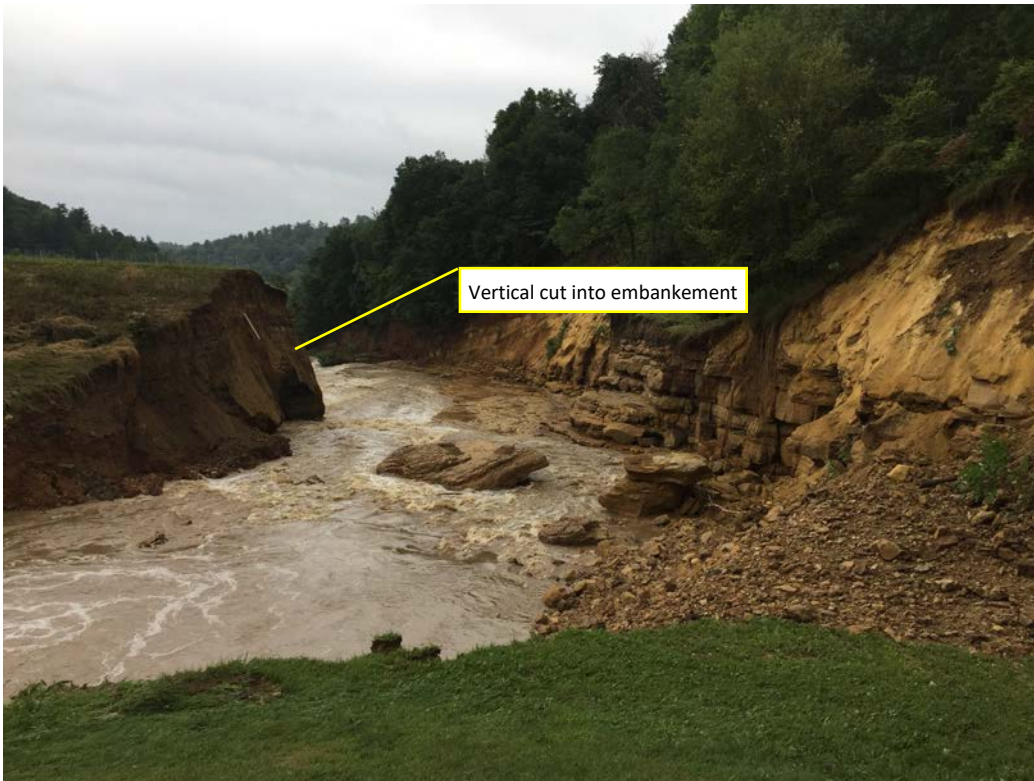
Photo 1
View of Breach Channel from Upstream
(WFK 1)

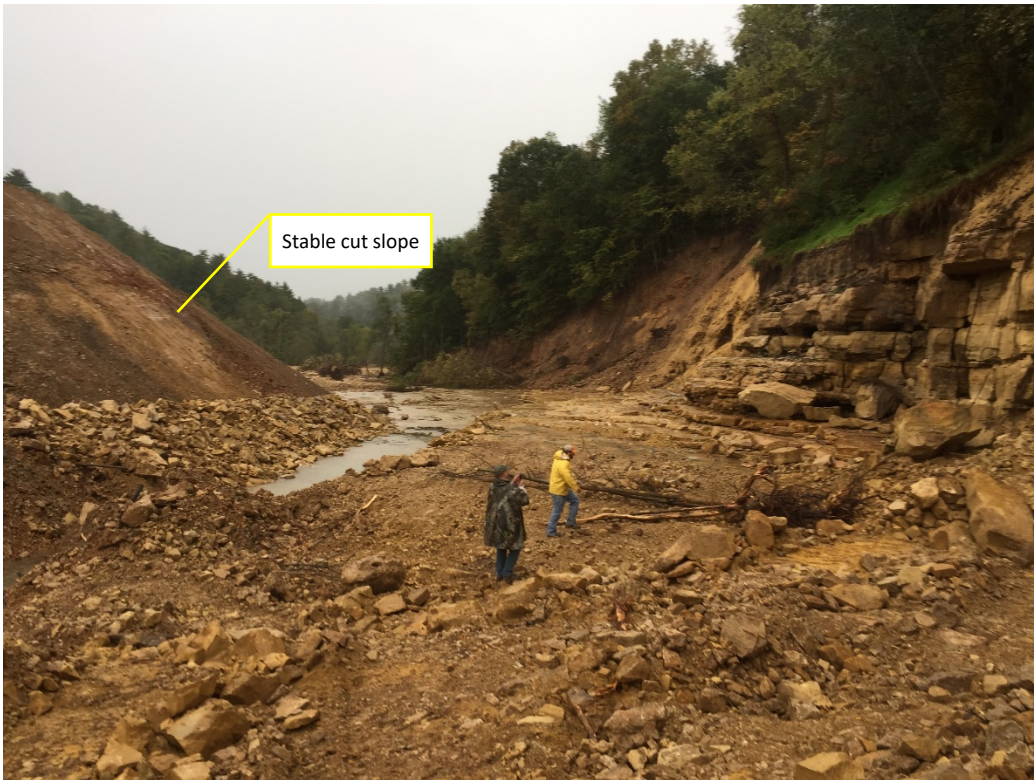
Photo 2
View of Breach Channel from Upstream
(WFK 1)

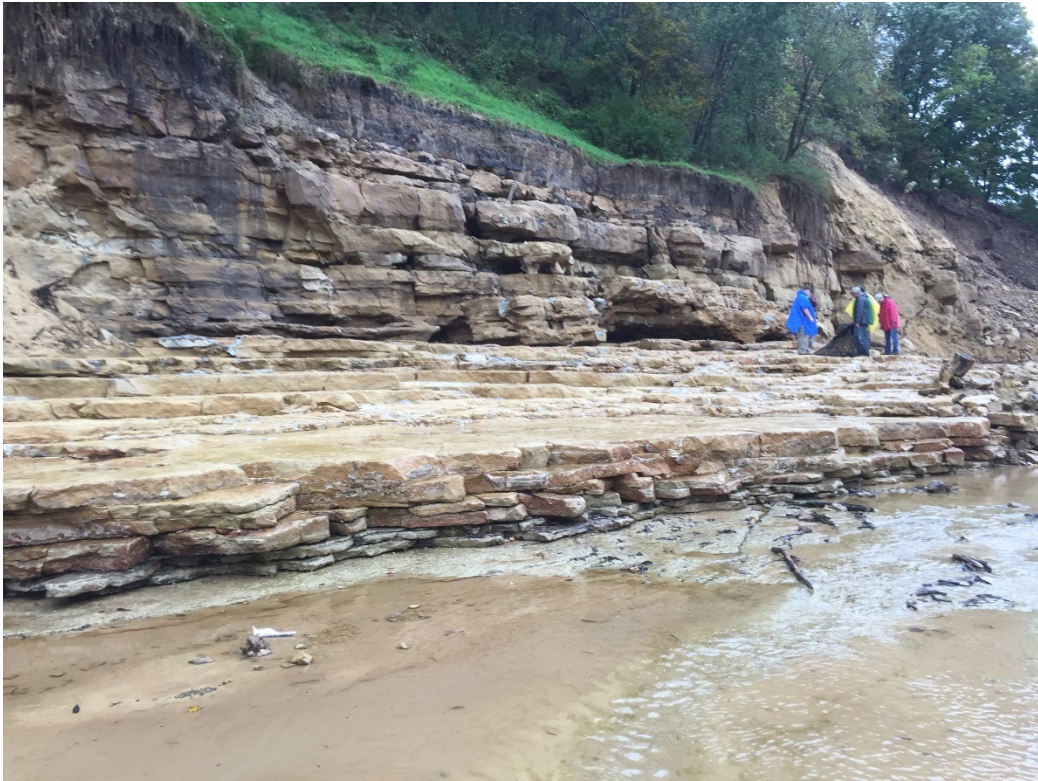
Photo 3
Exposed right abutment showing jointed bedrock
(WFK 1)

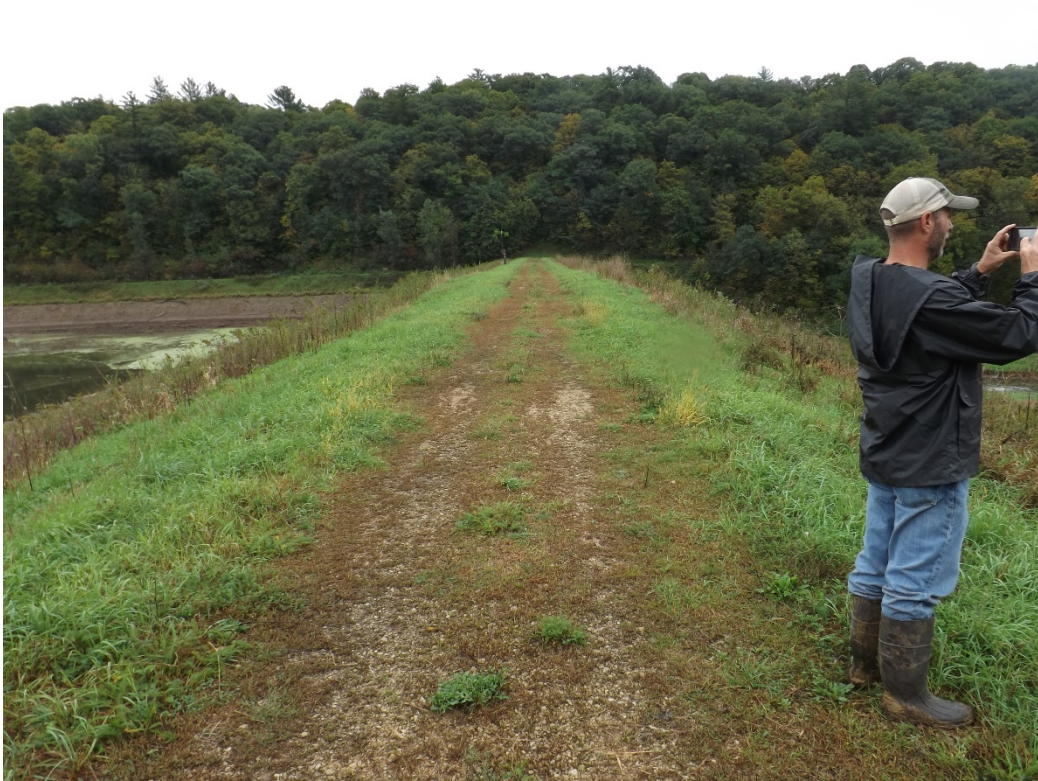
Photo 10
View of top of dam from right end near top of cut slope.
(WFK 1)

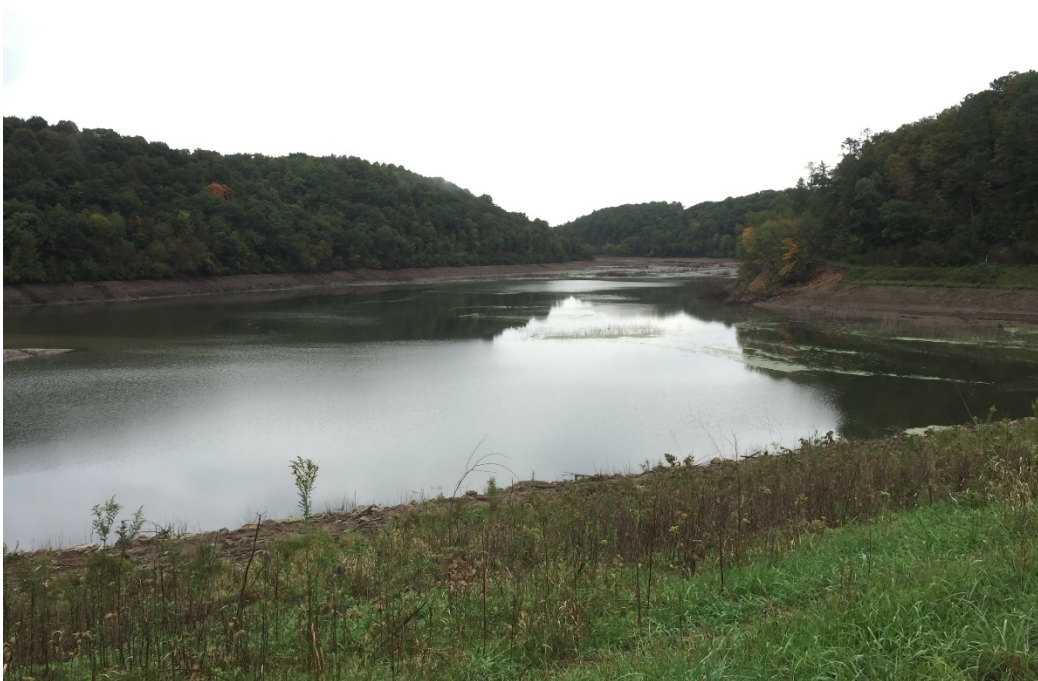
Photo 11
View of upstream pool from beach area.
(WFK 1)

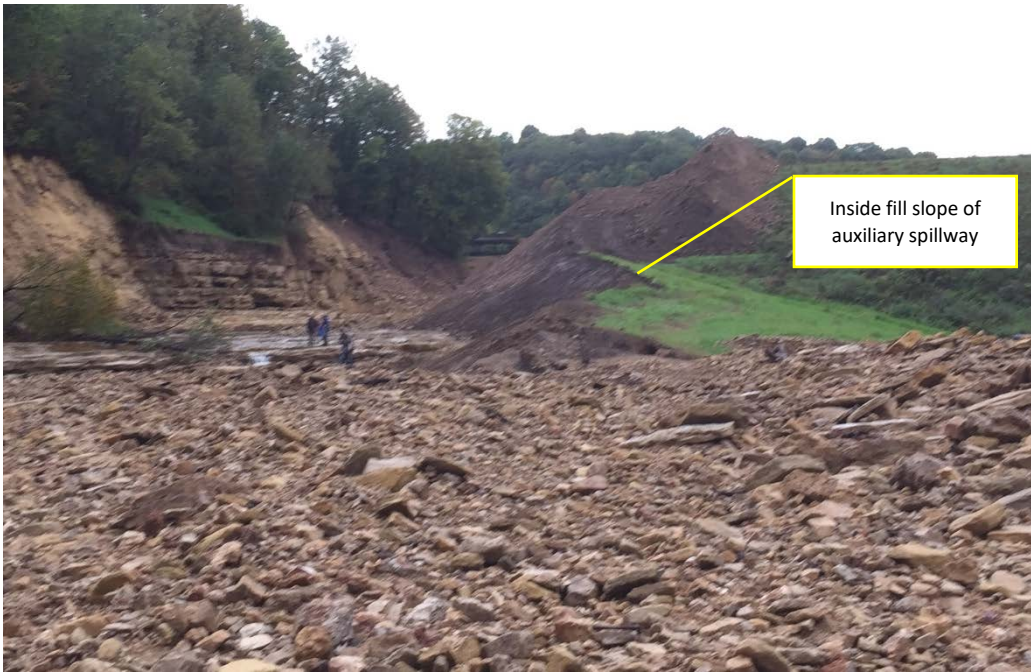
Photo 12
View of breach channel and left end of dam from downstream of dam.
(WFK 1)

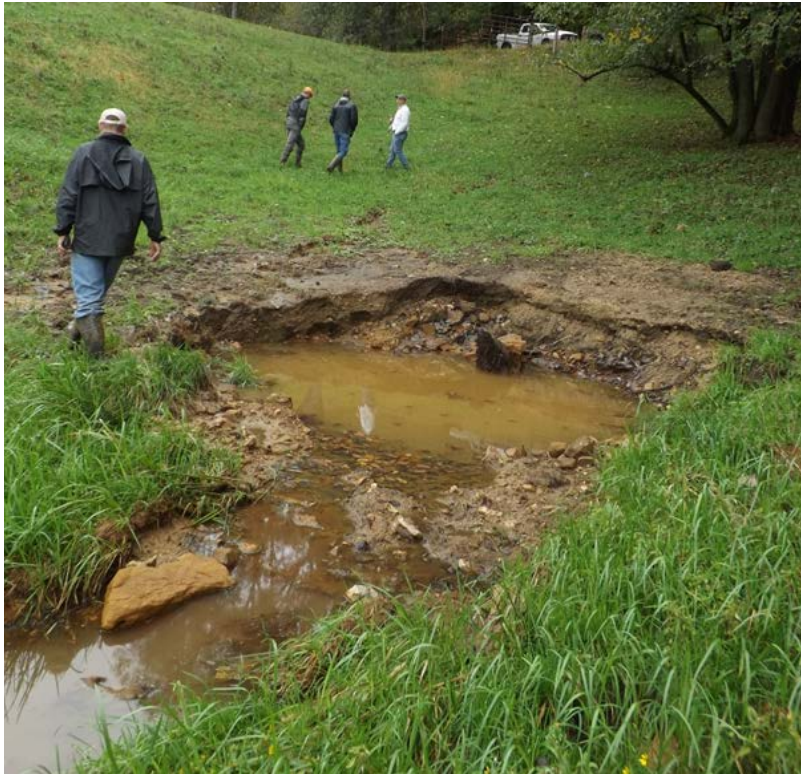
Photo 16
Scour hole at toe of left downstream groin.
(WFK MLSNA)

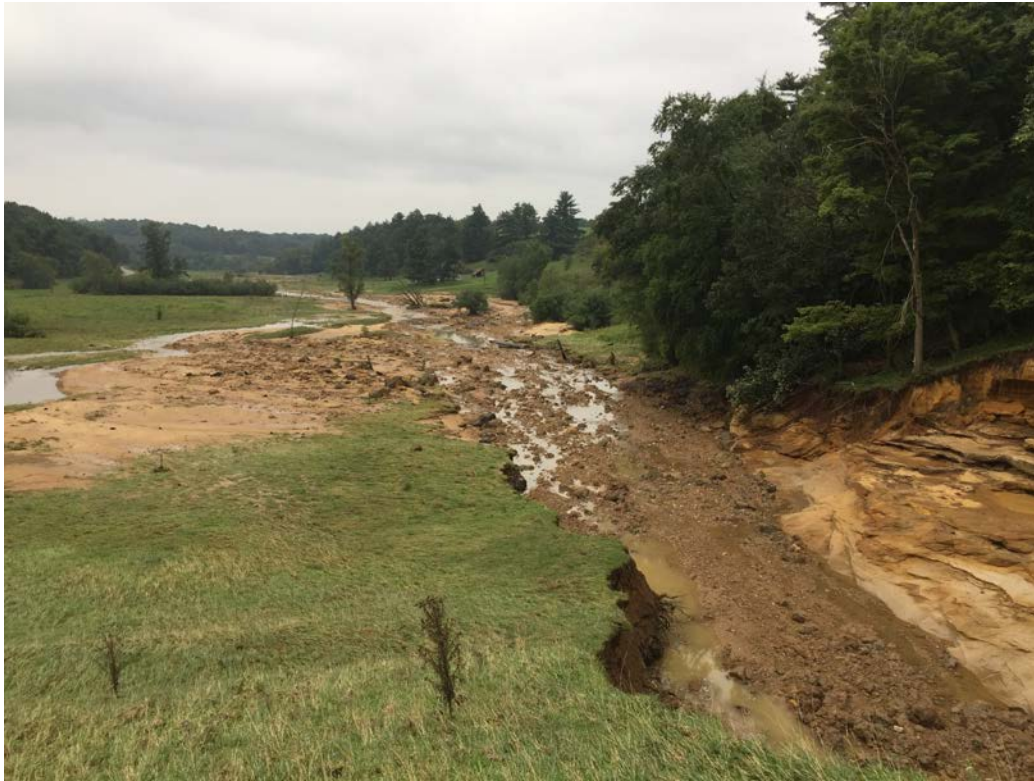
Photo 24
View of breach inundation area from top of dam.
(WFK MLSNA)

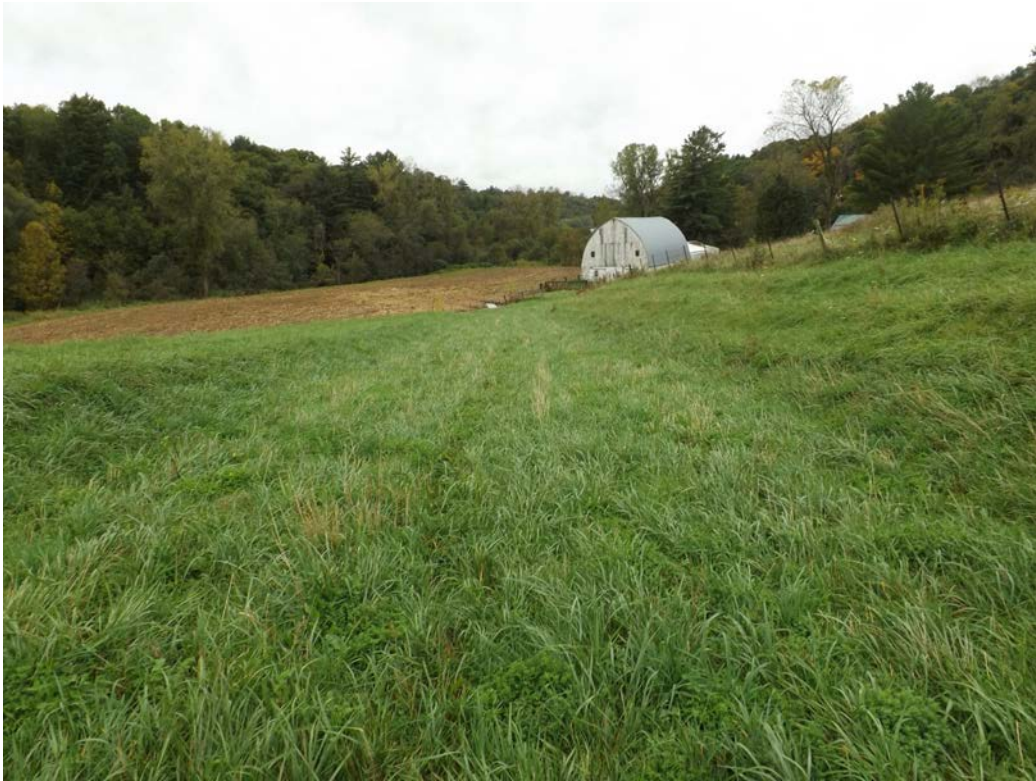
Photo 28
Exit channel of auxiliary spillway.
(WFK 3)

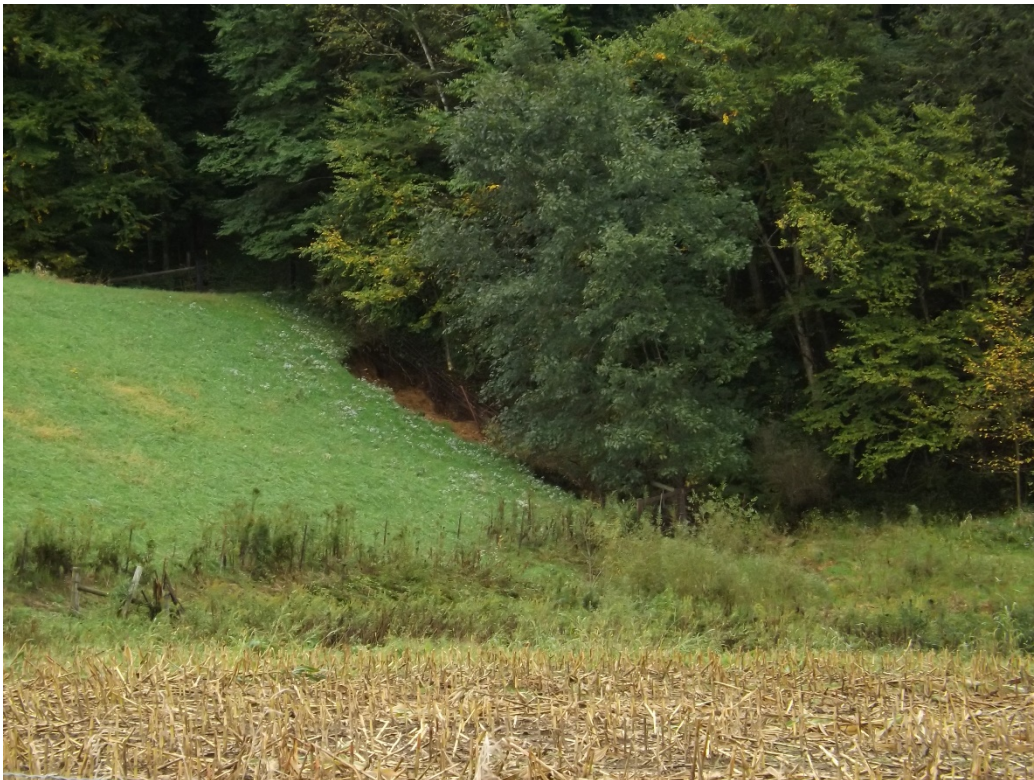
Photo 31
Erosion in left groin.
(WFK 3)

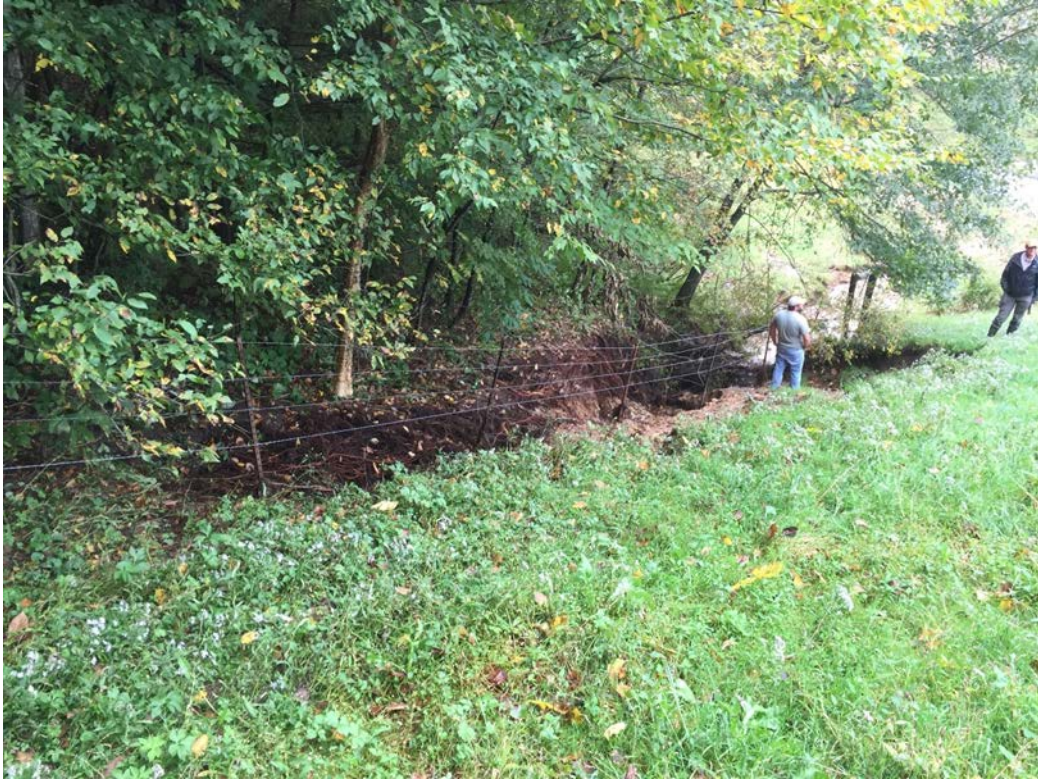
Photo 32
View of erosion in left groin from top of dam.
(WFK 3)

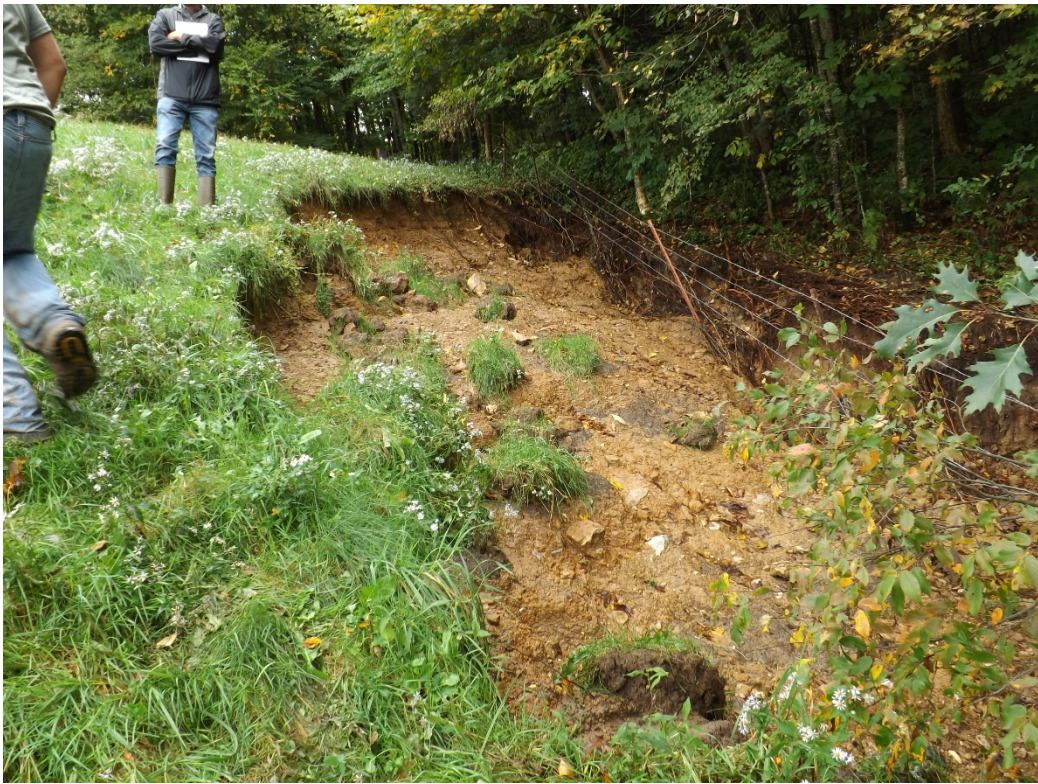
Photo 33
Erosion in left groin.
(WFK 3)

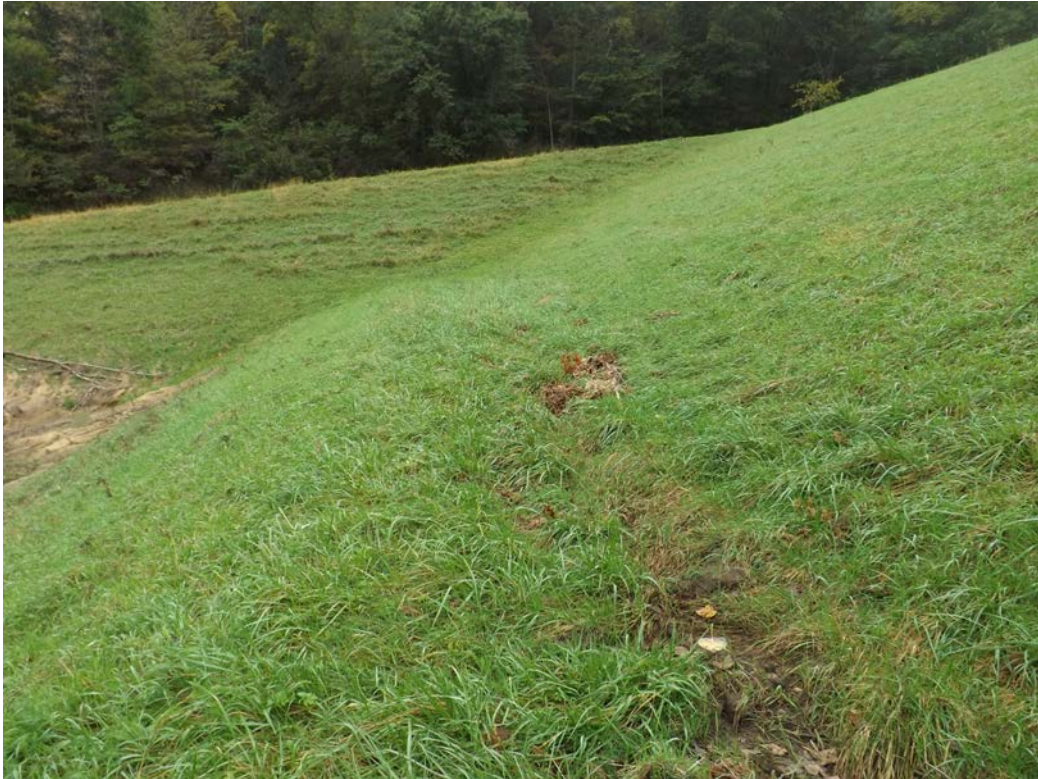
Photo 35
View of vegetation on downstream berm and embankment.
(CC 21)

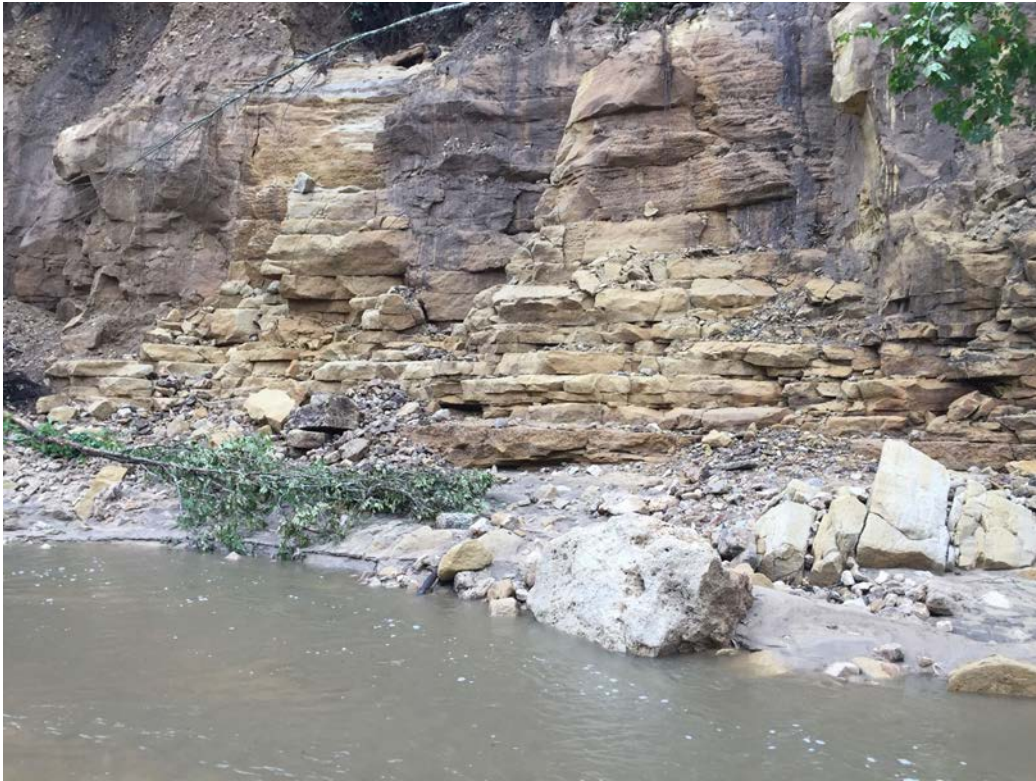
Photo 40
View of exposed bedrock in breach channel from near upstream toe of dam.
(CC 21)

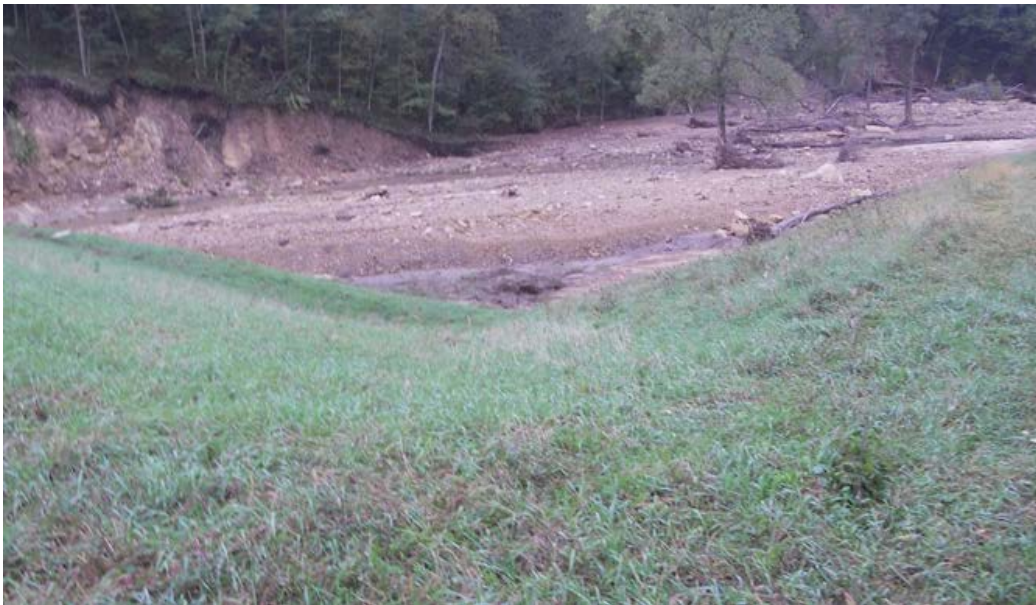
Photo 41
View of right downstream groin from top of dam.
(CC 21)

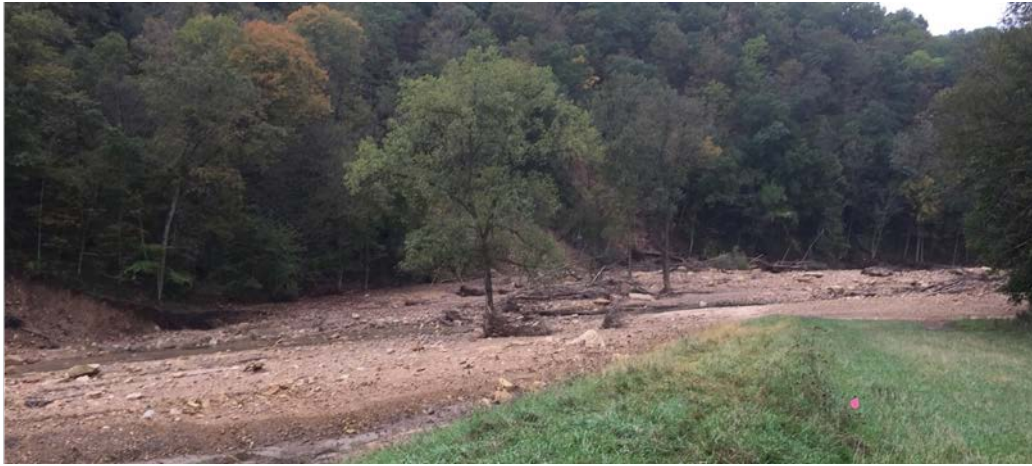
As with the other sites, it was a complete breach that cut down below the sediment pool behind the dam. Evidence of a sudden breach through the abutment bedrock can be seen in the extensive debris field downstream which consists of fragments of bedrock material (see Attachment B, Photo 42). A post-breach survey of the breach estimated the eroded material volume at 28,000 cubic yards.

Photo 42
View downstream of dam of outwash from left abutment.
(CC 21)

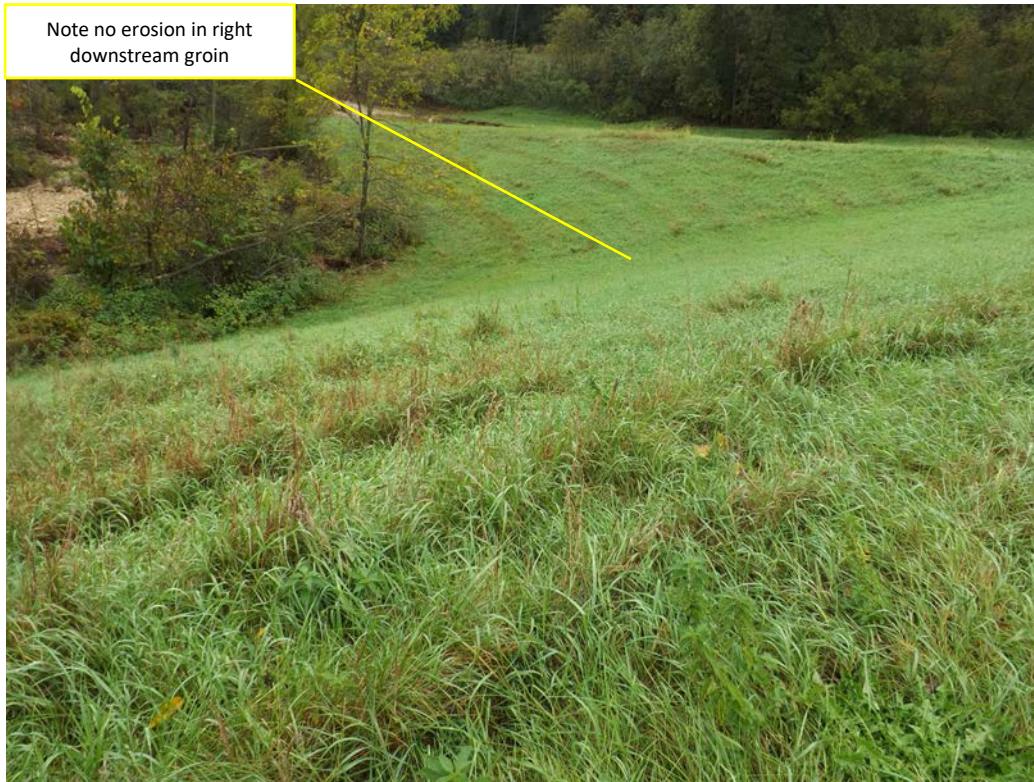
The committee traveled next to CC-29 in the afternoon. The vegetative cover on this site was excellent and overall maintenance appeared to be good (see Attachment B, Photo 43). The dam overtopped on this site and there was significant damage to the auxiliary spillway (see Attachment B, Photo 44). The auxiliary spillway is a ramped spillway with an 80 ft. wide bottom. The extent of the erosion channel, at the time of the breach, extended well over half the bottom width with a three to four-foot-deep headcut. The headcut advanced to within about 30 feet of the level section of the auxiliary spillway (see Attachment B, Photos 45 through 47). The extensive damage to the auxiliary spillway suggests that it was close to breaching at the time the breach occurred at the left end of the dam.

Photo 43
View of downstream embankment and auxiliary spillway dike vegetation from top of dam.
(CC 29)

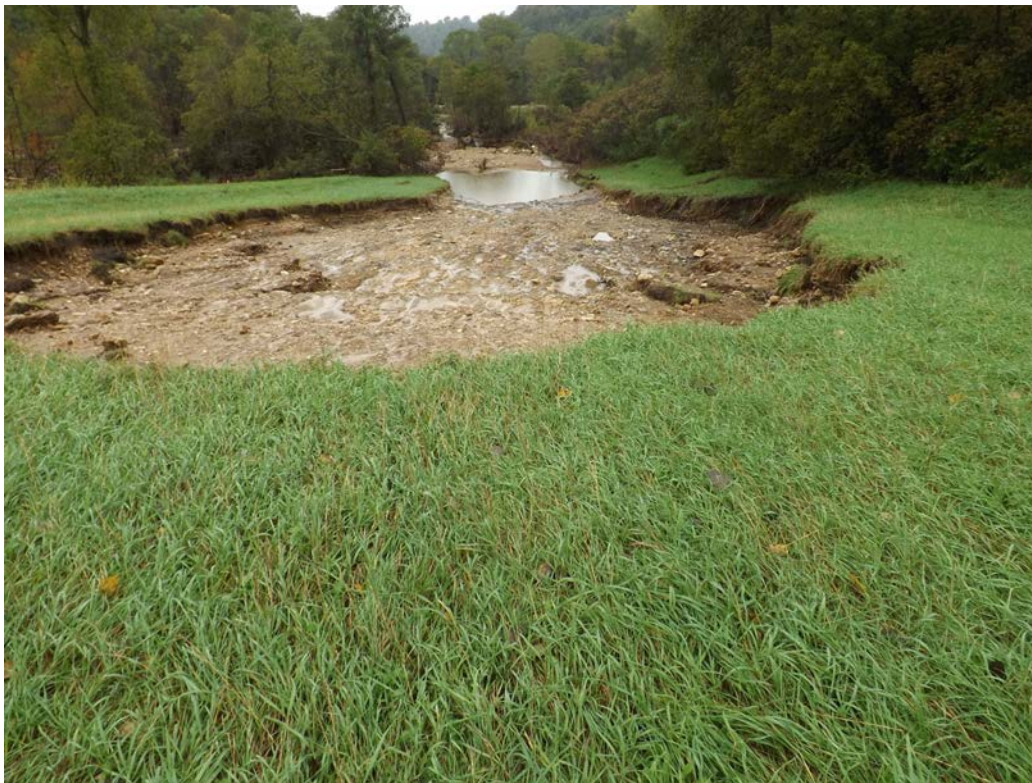
Photo 45
View of auxiliary spillway exit channel from level section.
(CC 29)

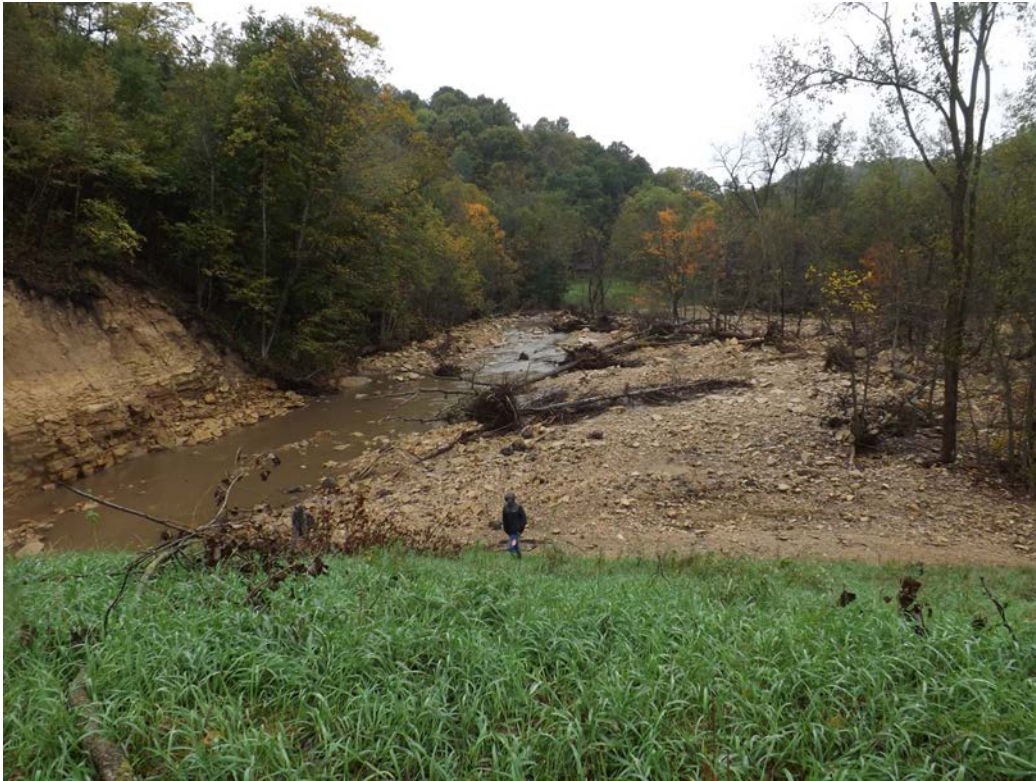
Photo 54
View of debris in breach inundation area from top of dam.
(CC 29)

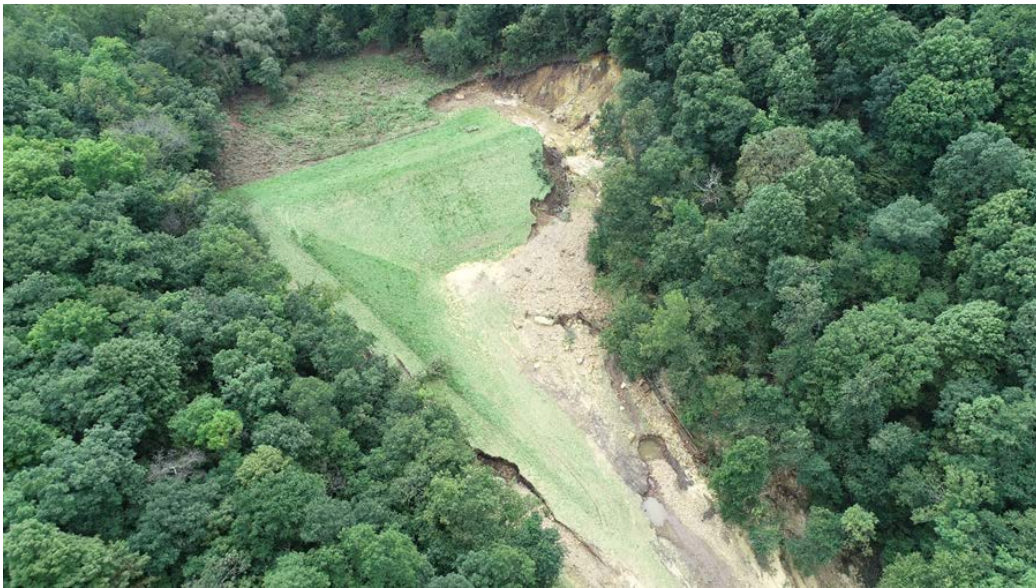
The committee traveled last to CC-23. The vegetative cover on the dam appears to be in excellent condition (see Attachment B, Photos 55 and 56). Overall maintenance appeared to be in good condition. The breach wave shifted an unoccupied ranch house off its foundation and washed out a small bridge on a town road just downstream of the house. The house is located approximately 0.4 mile downstream of the dam (see Attachment B, Photos 57 through 59).

Photo 55
Aerial view of structure site.
(CC 23)

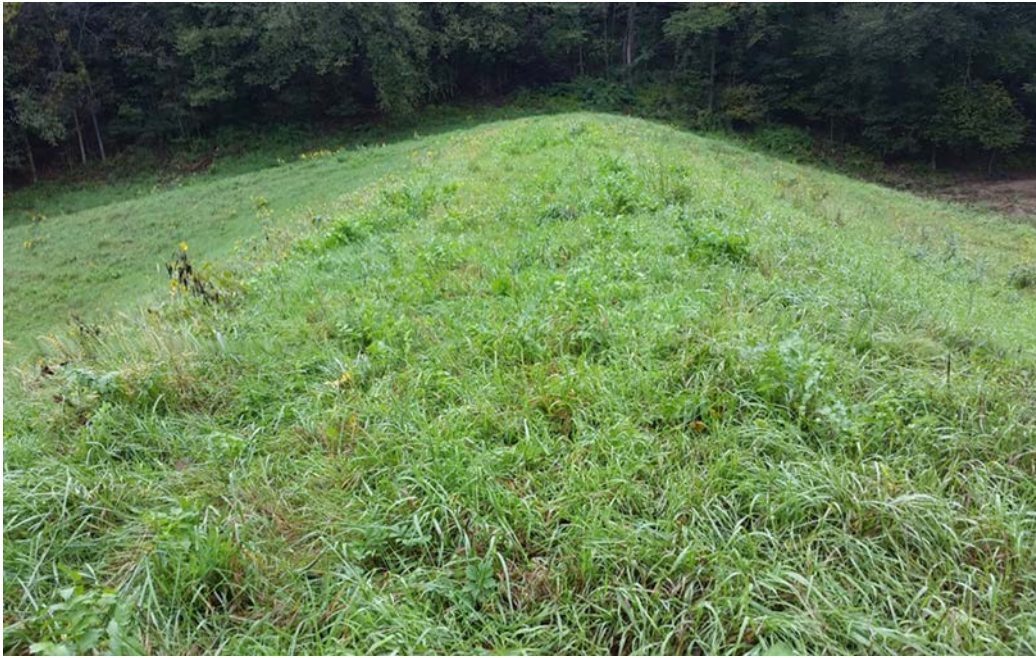
Photo 56
View of top of embankment from top left end of dam.
(CC 23)

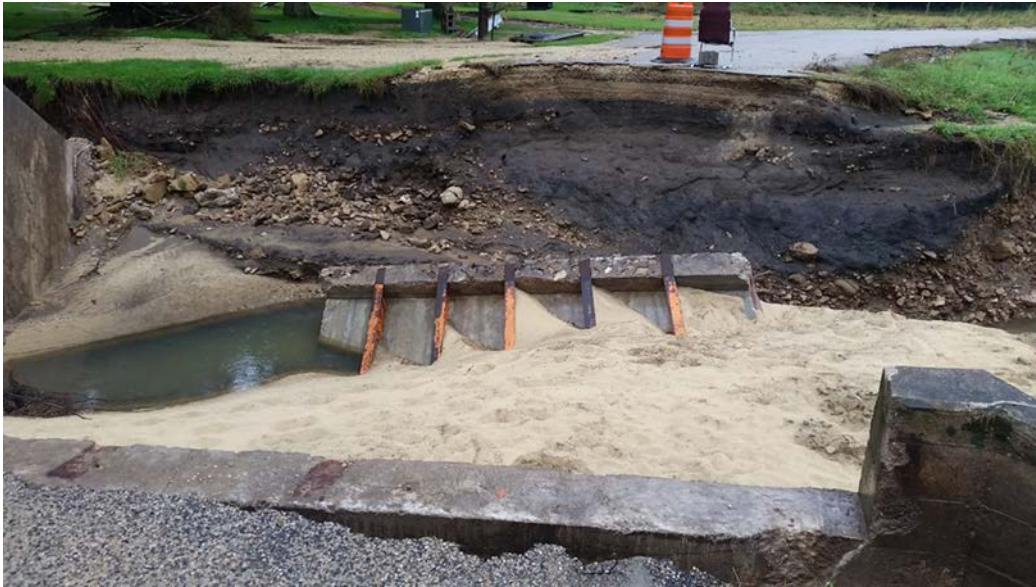
Photo 58
View from downstream county road of damaged house in breach inundation area.
(CC 23)

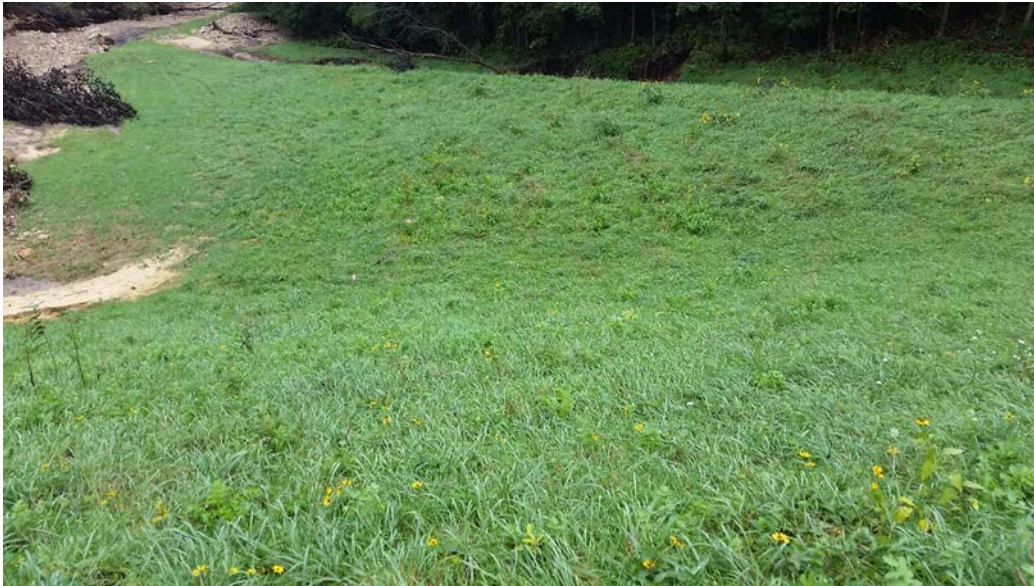
Photo 64

View of downstream side of embankment from outlet of auxiliary spillway exit channel.
(CC 23)

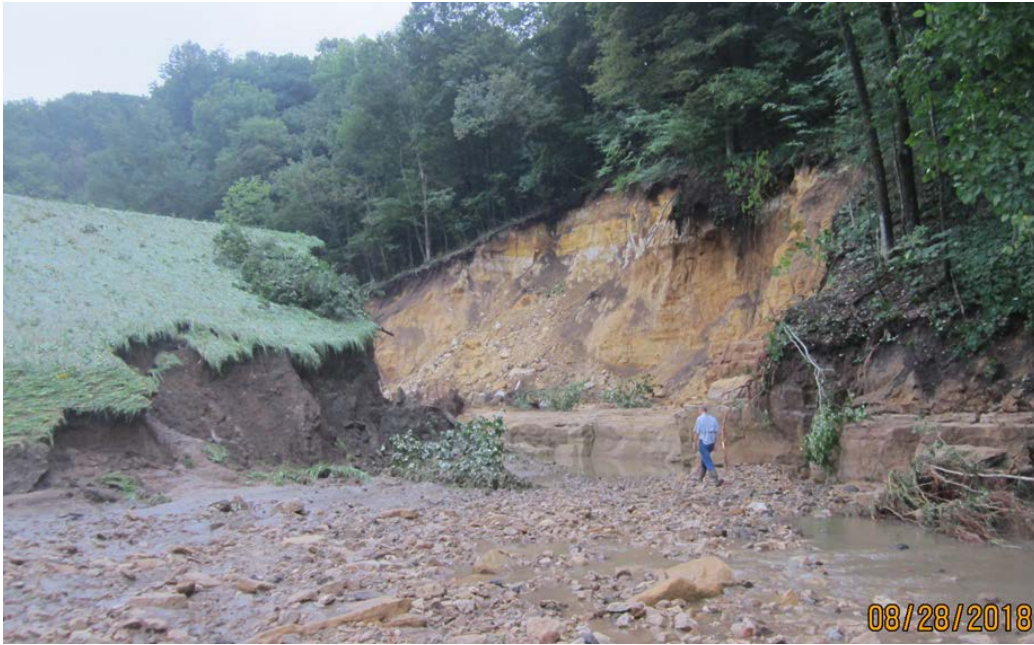
The breach eroded below the sediment pool upstream (see Attachment B, Photo 66). The erosion significantly extended into the abutment (see Attachment E, CC-23, Sheet 16, Plan View and Sheet 17, Cross Section, and Photos 67 through 69). A headcut approximately six feet deep eroded the bedrock at the bottom of the breach channel (see Attachment B, Photos 71 and 72). The exposed bedrock at this site revealed the widest vertical valley relief fractures of any of the sites (see Attachment B, Photos 71 through 73). The debris field in the breach inundation area of this site was extensive (see Attachment B, Photo 70). A post-breach survey estimate the eroded material volume at 15,000 cubic yards. The failure conditions at CC-23 are similar to CC-21. Refer to the narrative on CC-21 and the Geology section for more detail.

Photo 66
Head cut into upstream sediment pool due to breach of dam.
(CC 23)

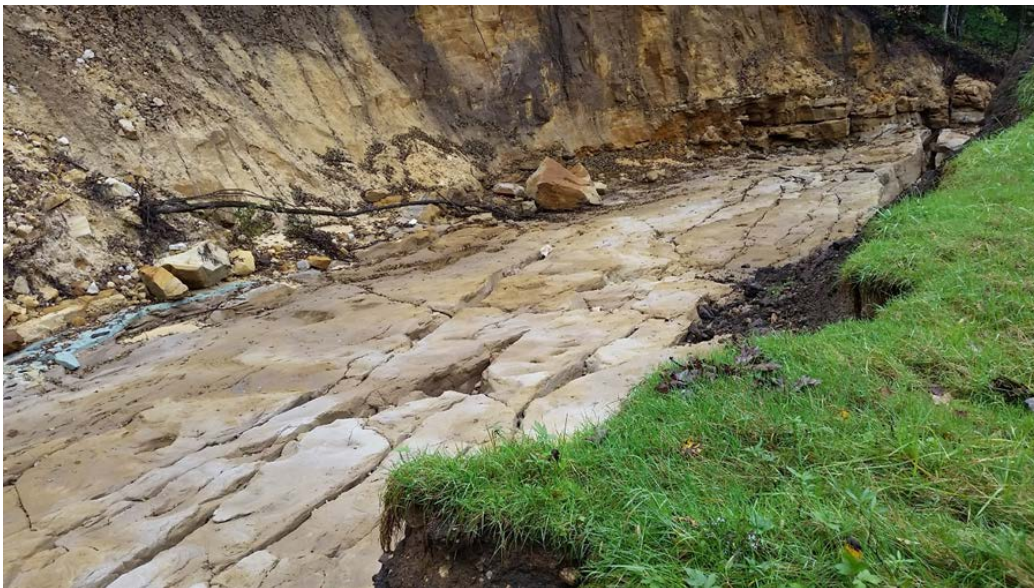
Photo 67
View of breach channel from downstream of dam.
(CC 23)

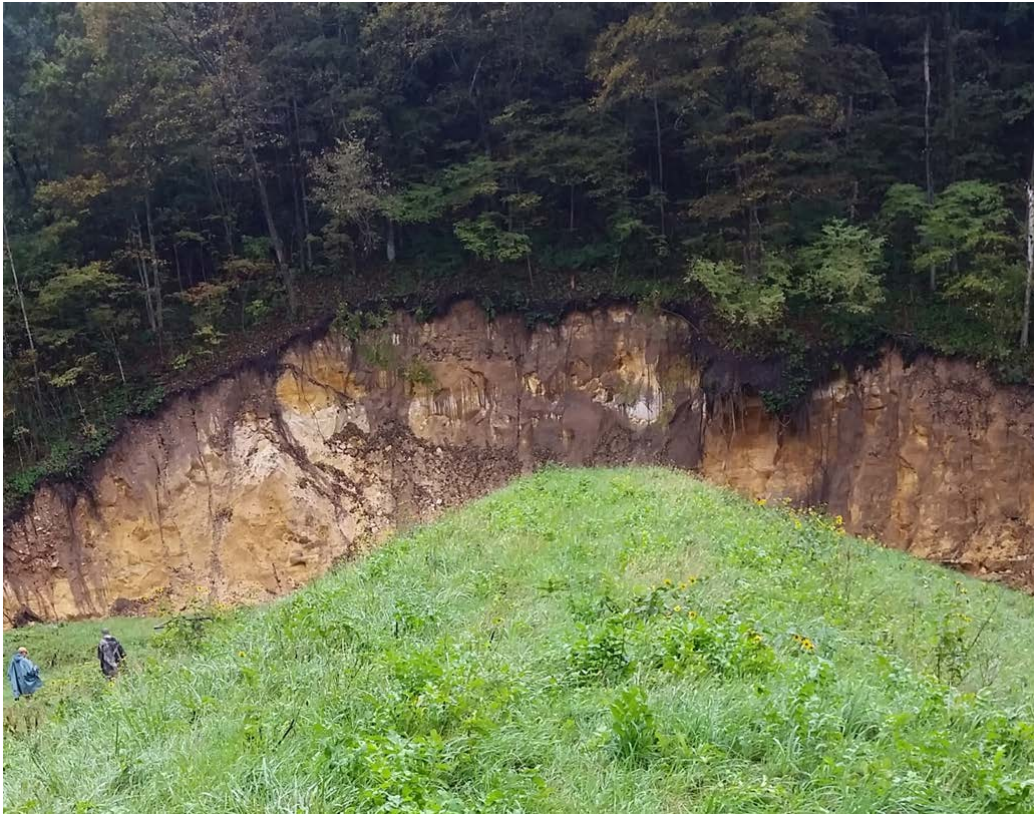
Photo 68
View of breach channel from upstream toe of dam.
(CC 23)

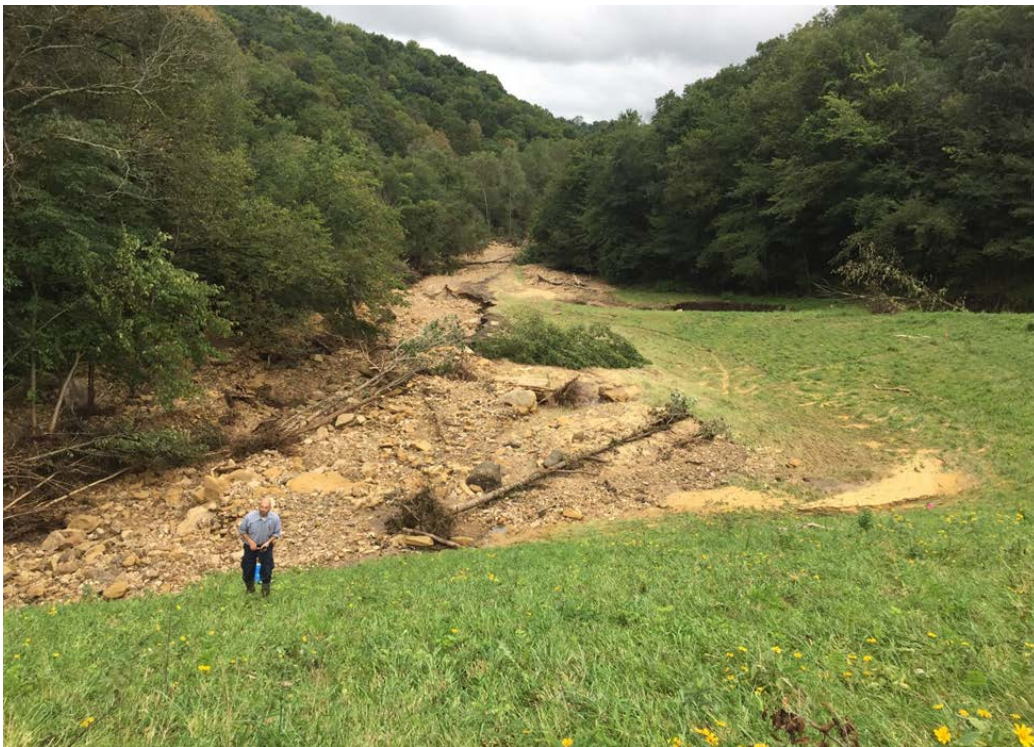
Photo 69
View of exposed bedrock in left abutment – breach channel.
(CC 23)

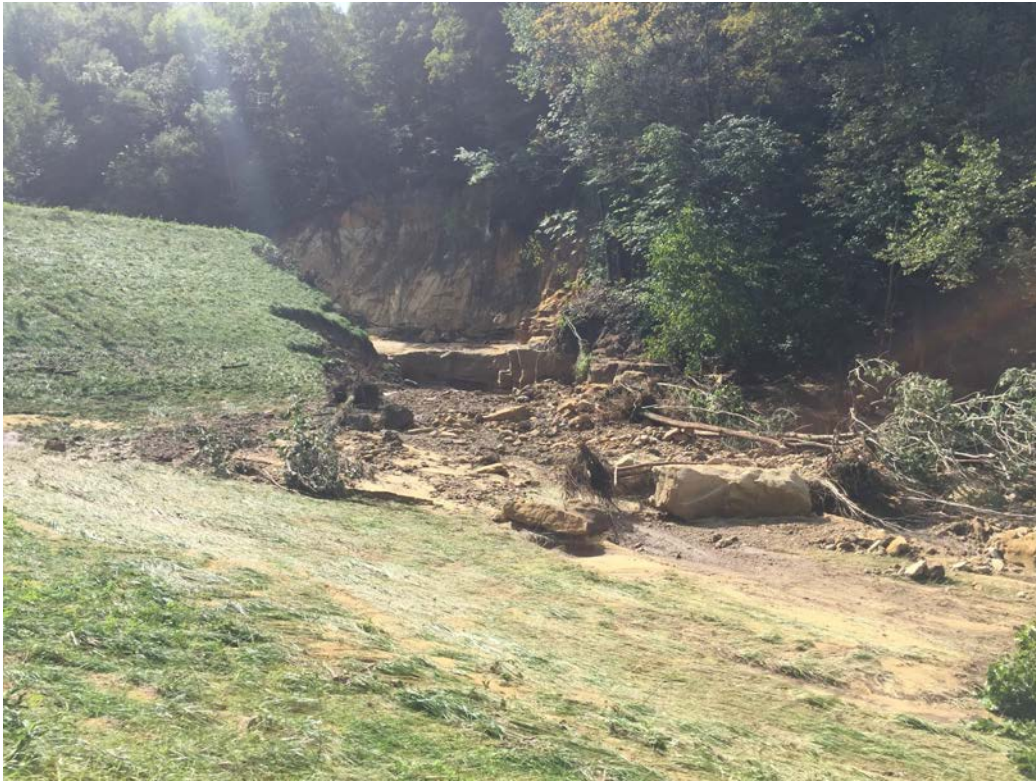
Photo 70
View of debris in breach inundation area downstream of dam.
(CC 23)
