INVESTIGATION REPORT FOR COON CREEK WATERSHED STRUCTURES 21, 23, AND 29,
AND WEST FORK KICKAPOO WATERSHED STRUCTURES MLSNA AND 1
MONROE AND VERNON COUNTIES, WISCONSIN

U.S. DEPARTMENT OF AGRICULTURE
NATURAL RESOURCES CONSERVATION SERVICE

June 26, 2019

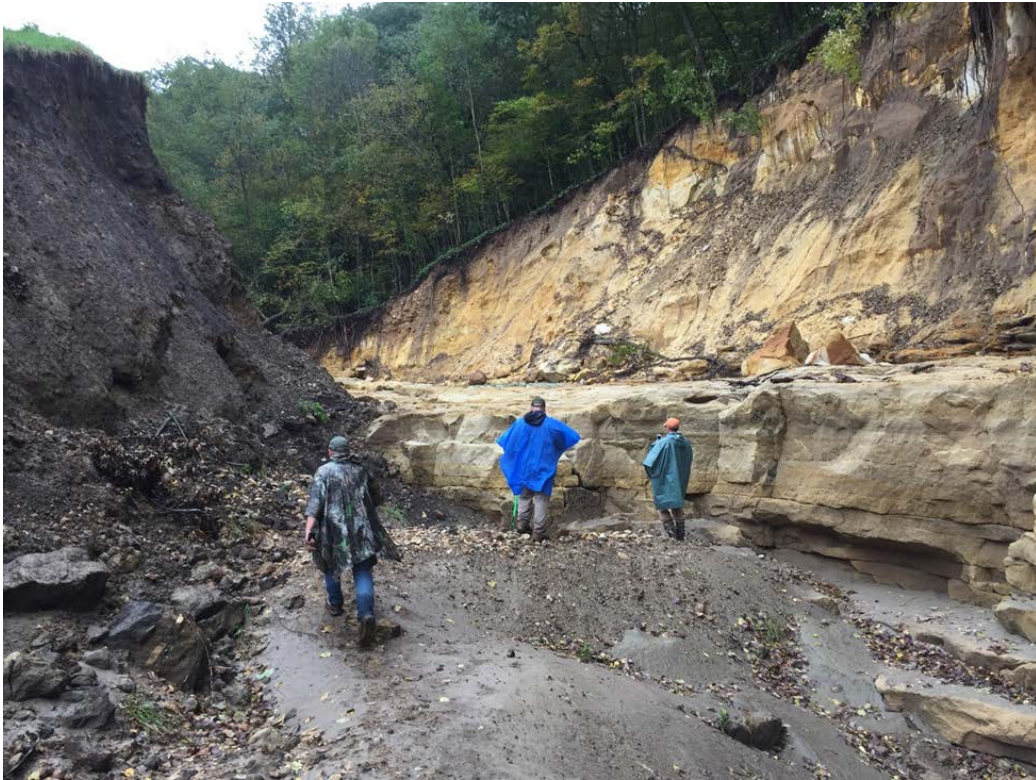
Photo 71
View of head cut into bedrock of breach channel.
(CC 23)

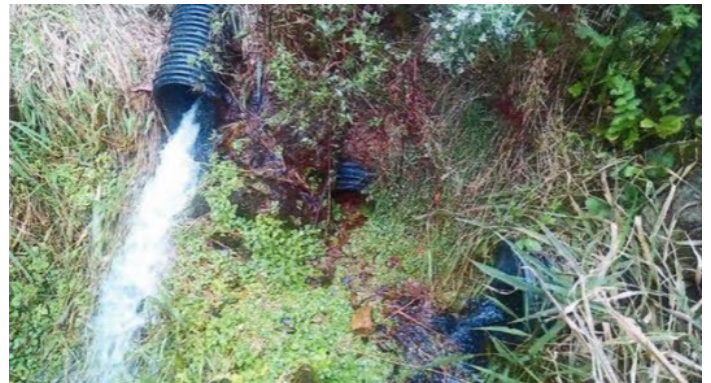
Seepage from Right Abutment Drains

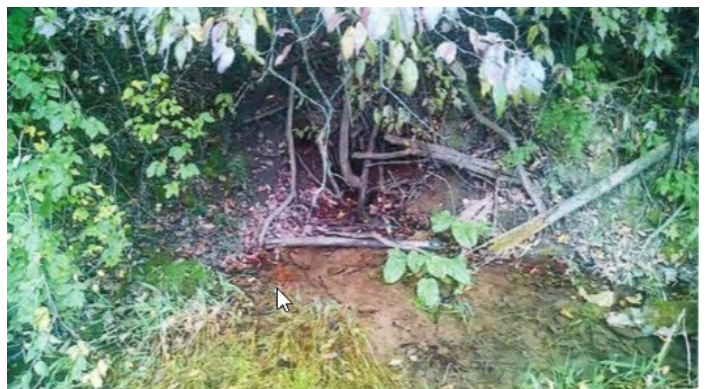
Seepage from Right Abutment Bedrock
