INVESTIGATION REPORT FOR COON CREEK WATERSHED STRUCTURES 21, 23, AND 29,
AND WEST FORK KICKAPOO WATERSHED STRUCTURES MLSNA AND 1
MONROE AND VERNON COUNTIES, WISCONSIN

U.S. DEPARTMENT OF AGRICULTURE
NATURAL RESOURCES CONSERVATION SERVICE

June 26, 2019

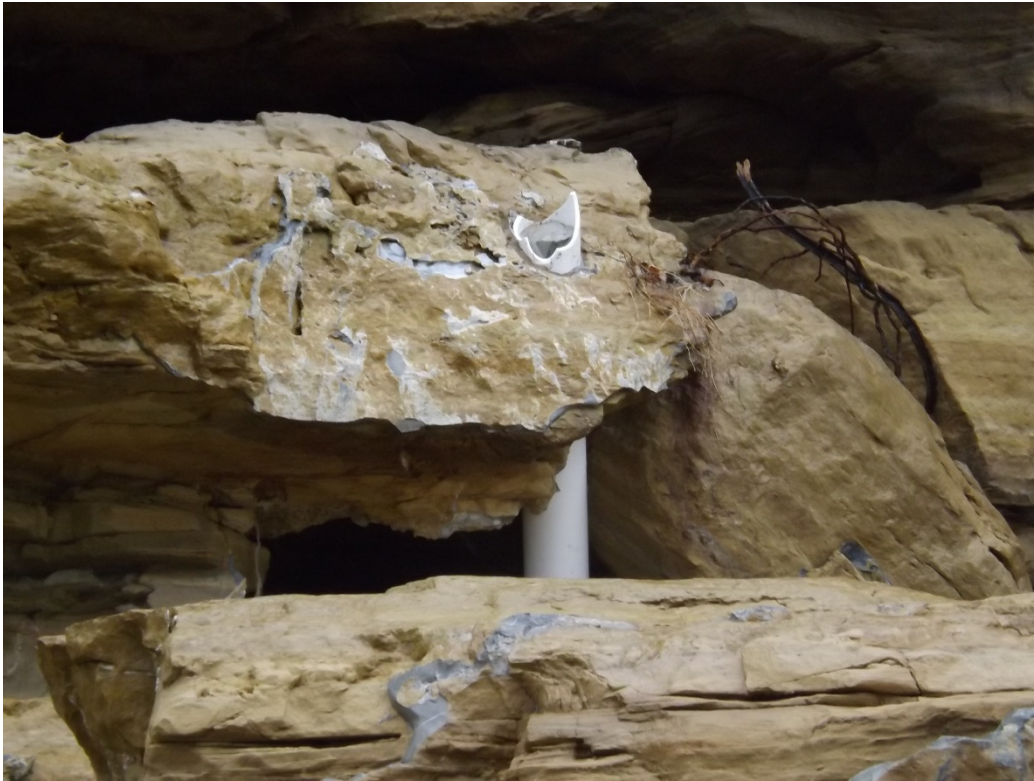
Photo 6

PVC and grout from 2009/2010 pressure grouting – right abutment near centerline dam. Note large voids in bedrock left by eroded sandstone.

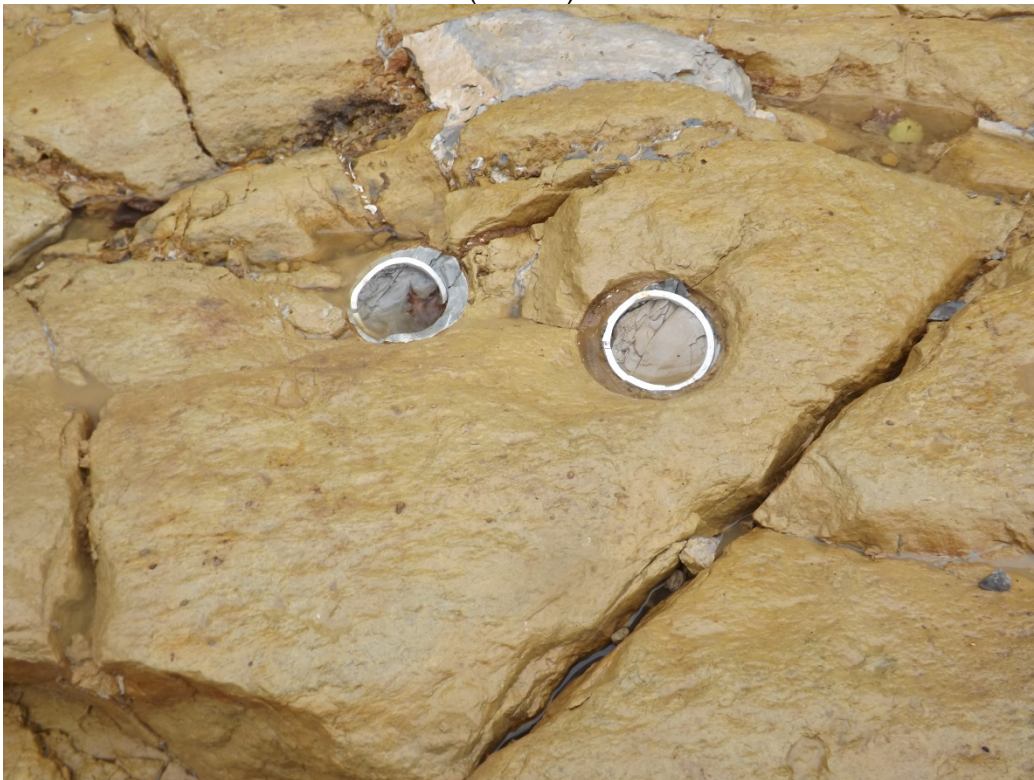
Photo 7

Remnant PVC and grout from 2009/2010 pressure grouting.

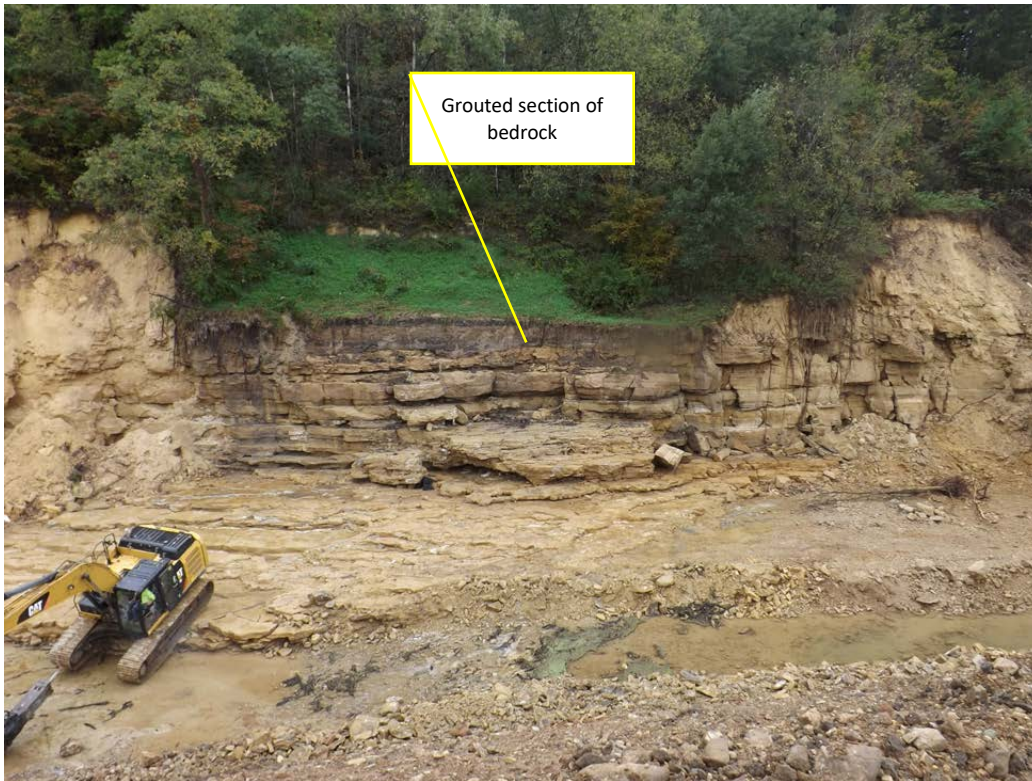
Photo 8

Breach channel from centerline top of dam. Note difference in stability of bedrock in curtain wall versus bedrock upstream and downstream.
(WFK 1)

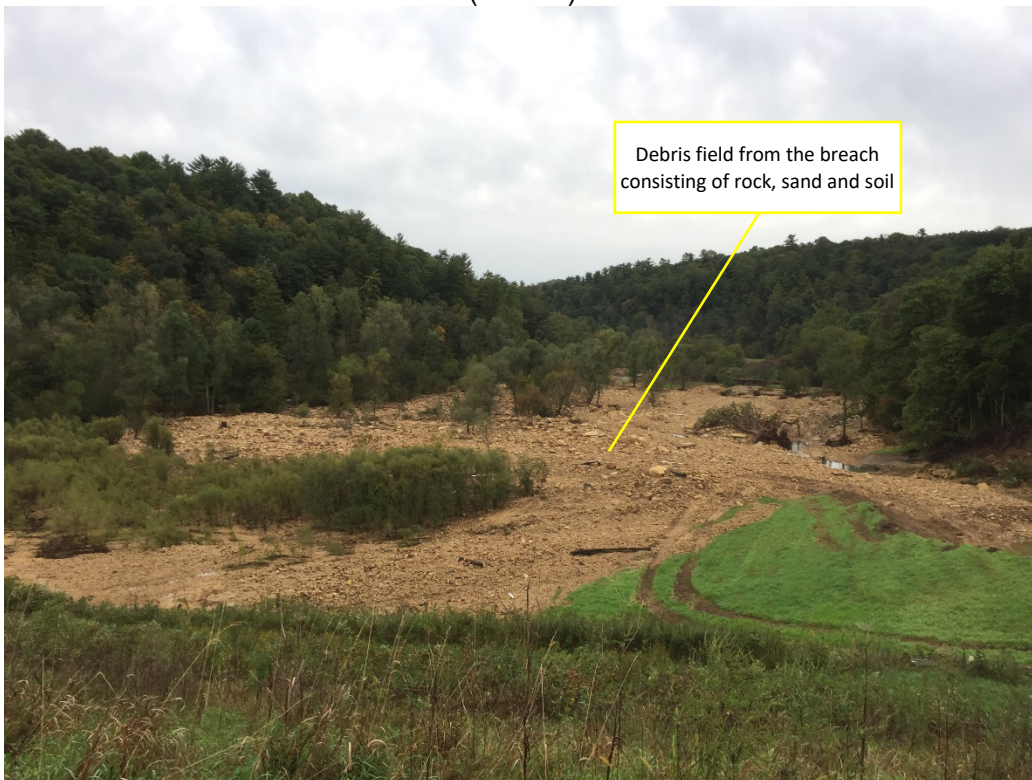
Photo 9

View of downstream breach inundation area from top of dam.
(WFK 1)

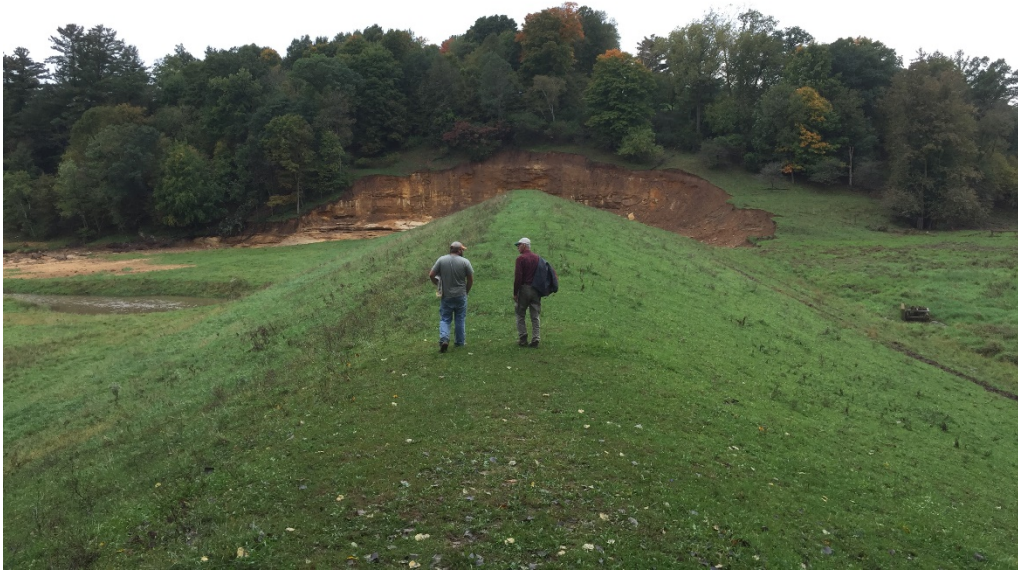
Photo 14

View of the embankment from the left end of dam with breach in background.
Note short vegetation due to grazing.

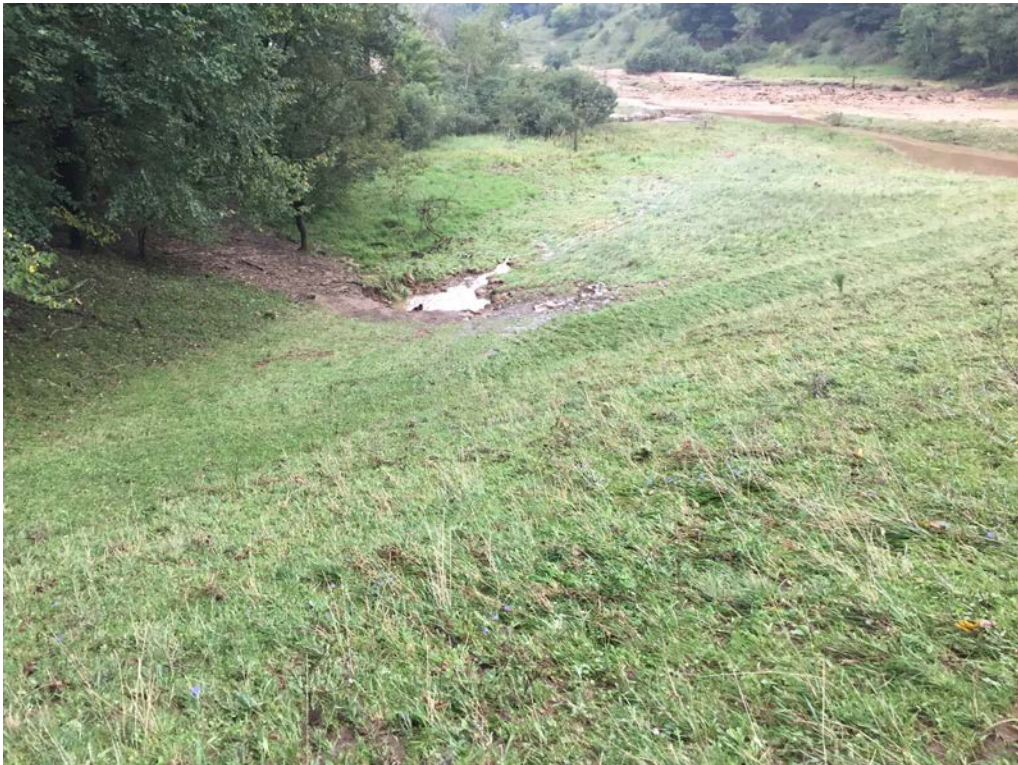
Photo 15

View of scour hole at the toe of the left downstream groin from the top of dam.

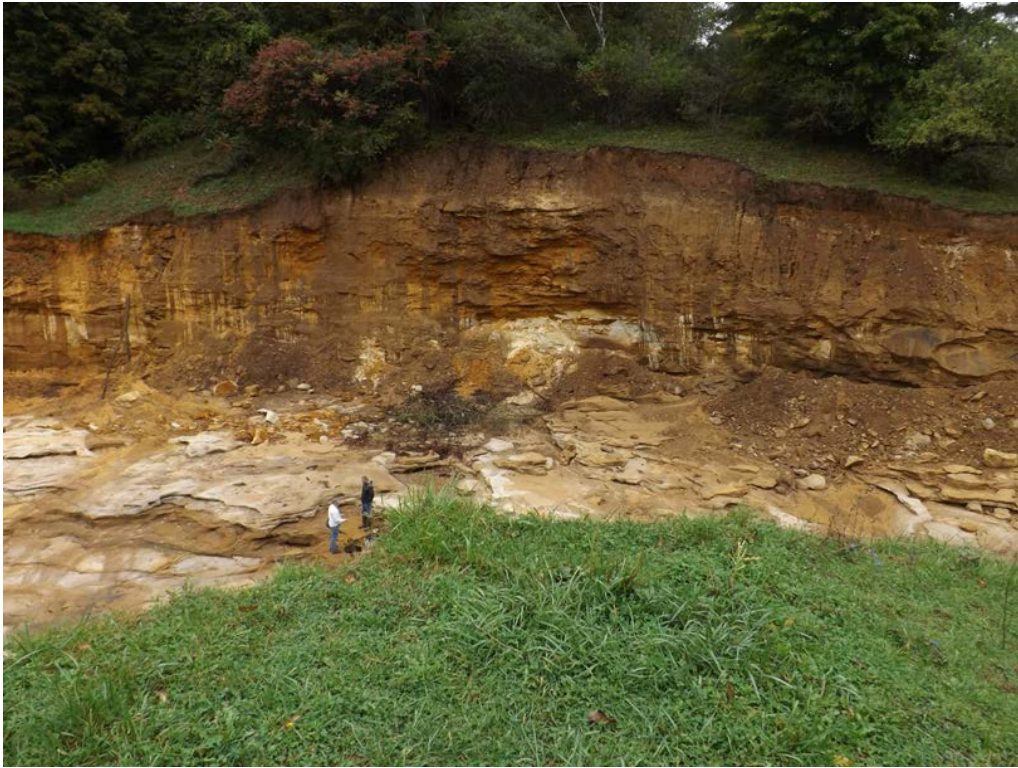
Photo 18

View of exposed bedrock in breach channel (right abutment) from top of dam.
(WFK MLSNA)

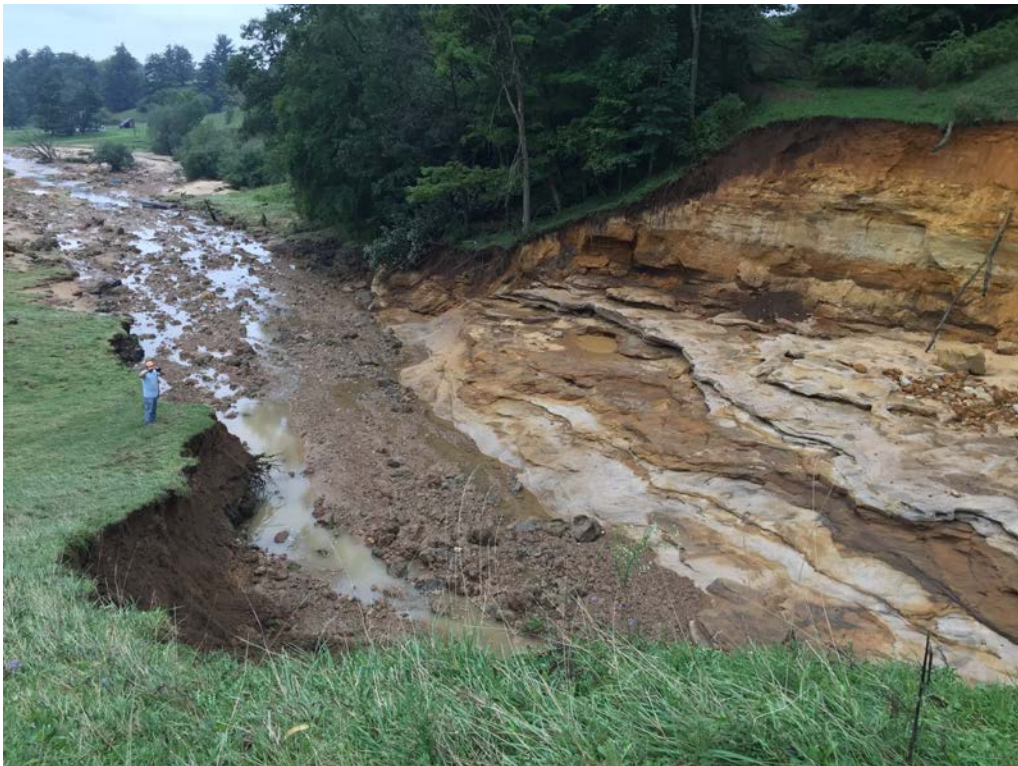
Photo 19

View of downstream section of breach channel showing right abutment bedrock from top of dam.
(WFK MLSNA)

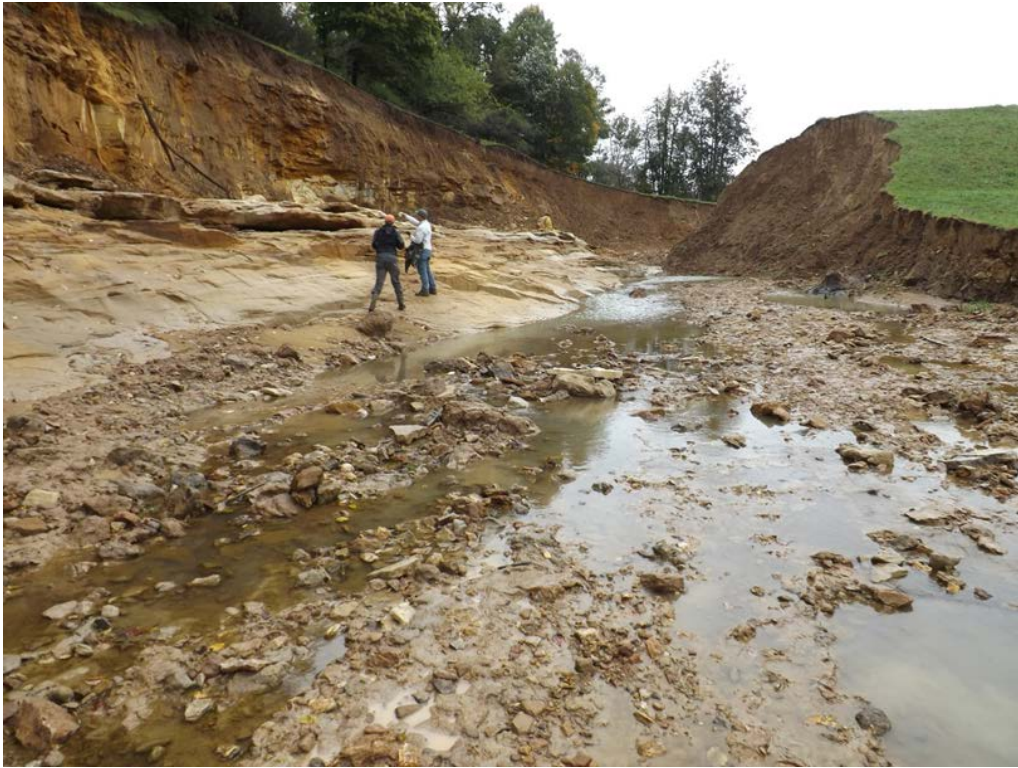
Photo 20

View looking upstream of exposed bedrock in the breach channel (right abutment) from the downstream end of the breach channel.
(WFK MLSNA)

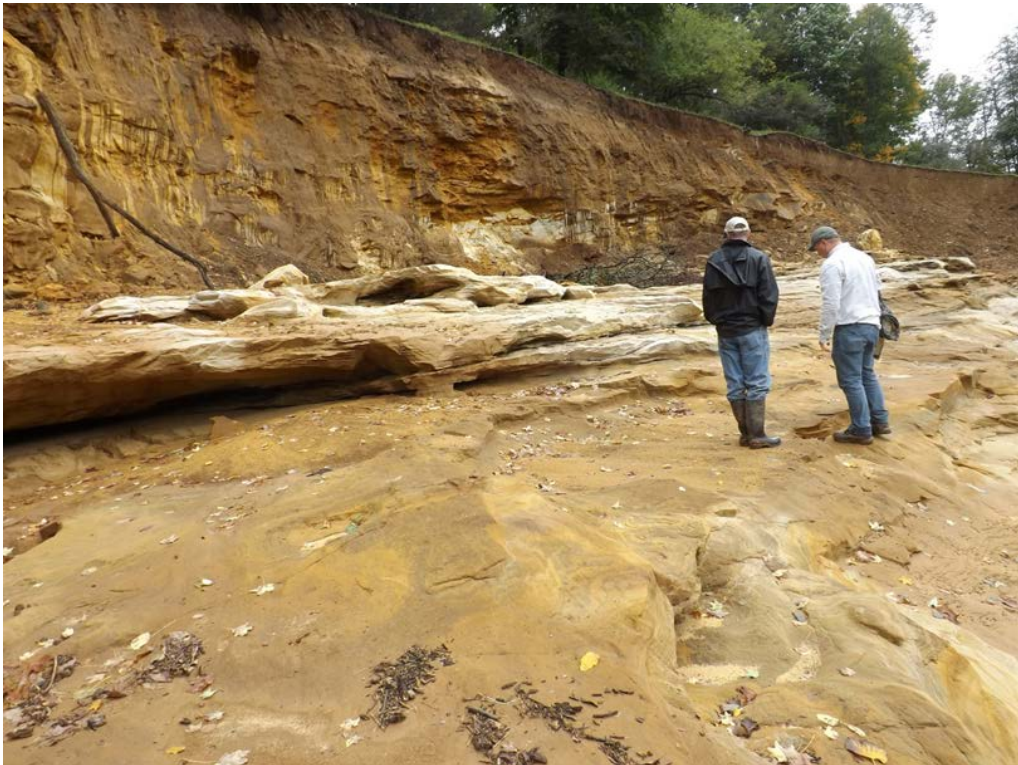
Photo 21

Close up of bedrock in breach channel.
(WFK MLSNA)

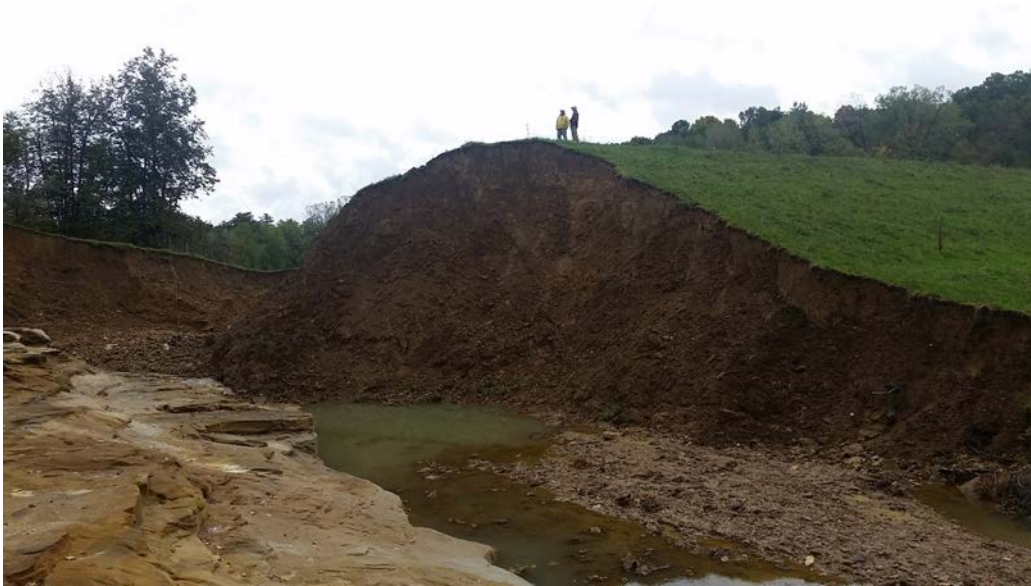
Photo 22

View of right end of dam in breach channel from the downstream end of the breach channel.
(WFK MLSNA)

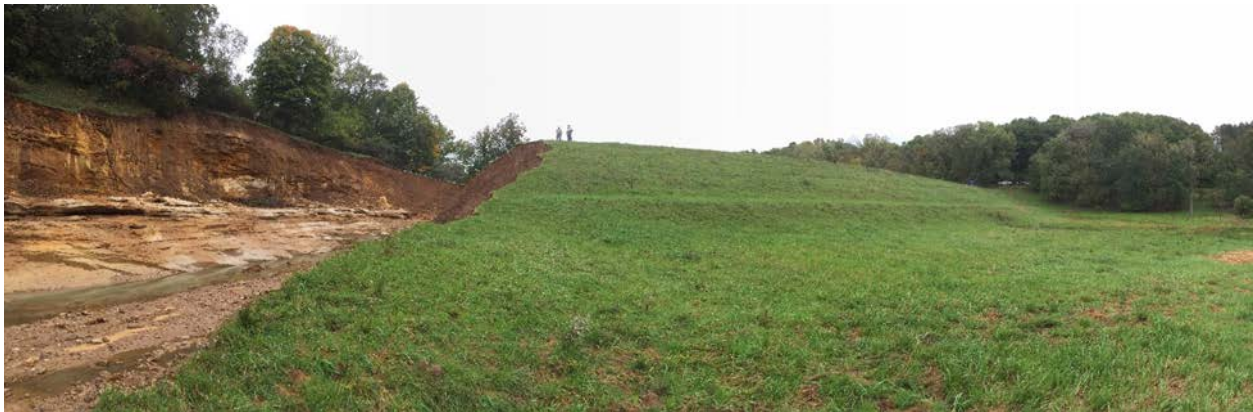
Photo 23

View of dam from abutment to abutment from downstream of dam.
(WFK MLSNA)

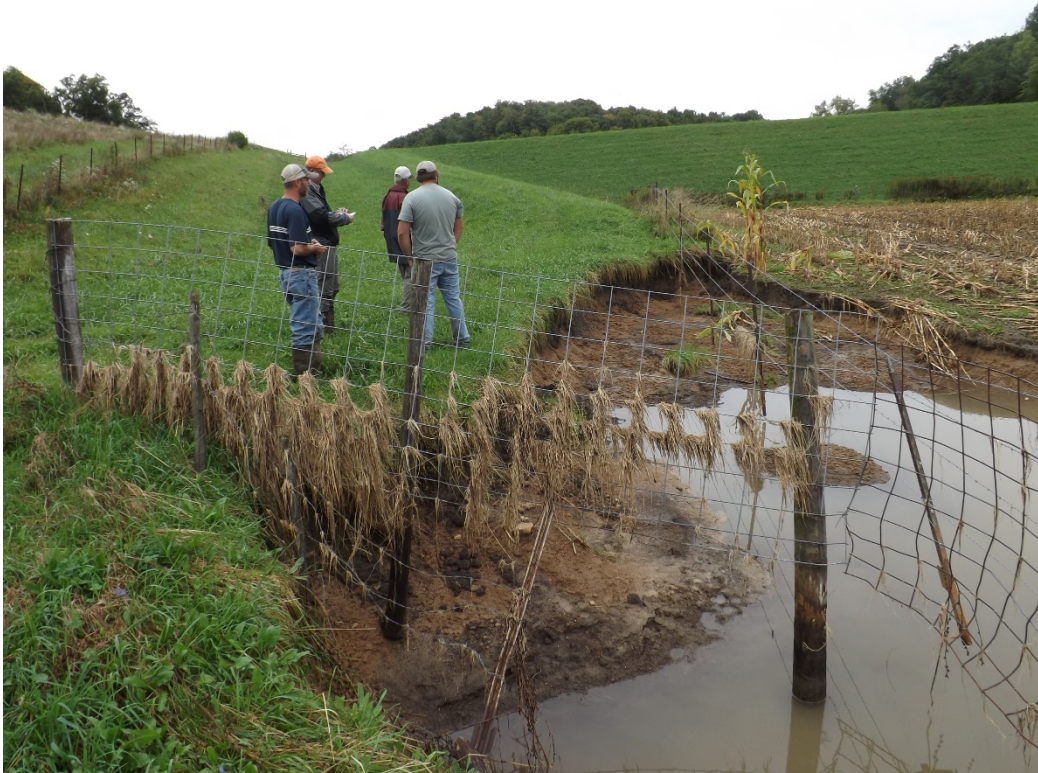
Photo 26

View of scour hole at downstream end of auxiliary spillway from downstream side.
(WFK 3)

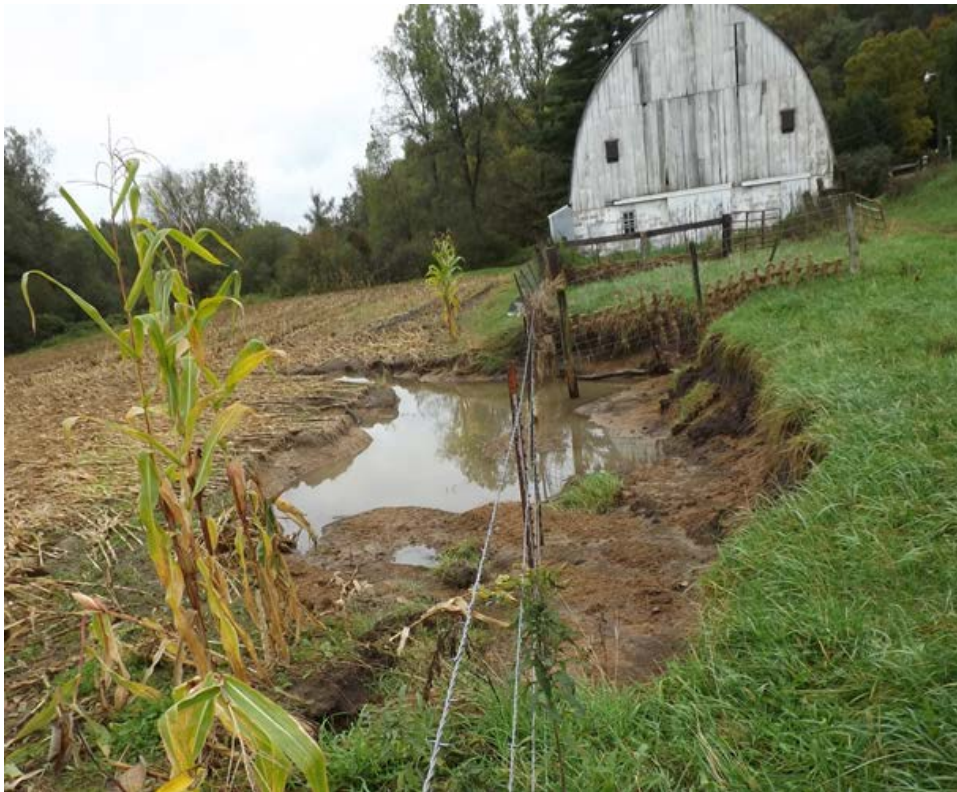
Photo 27

View of scour hole at downstream end of auxiliary spillway from upstream side.
(WFK 3)

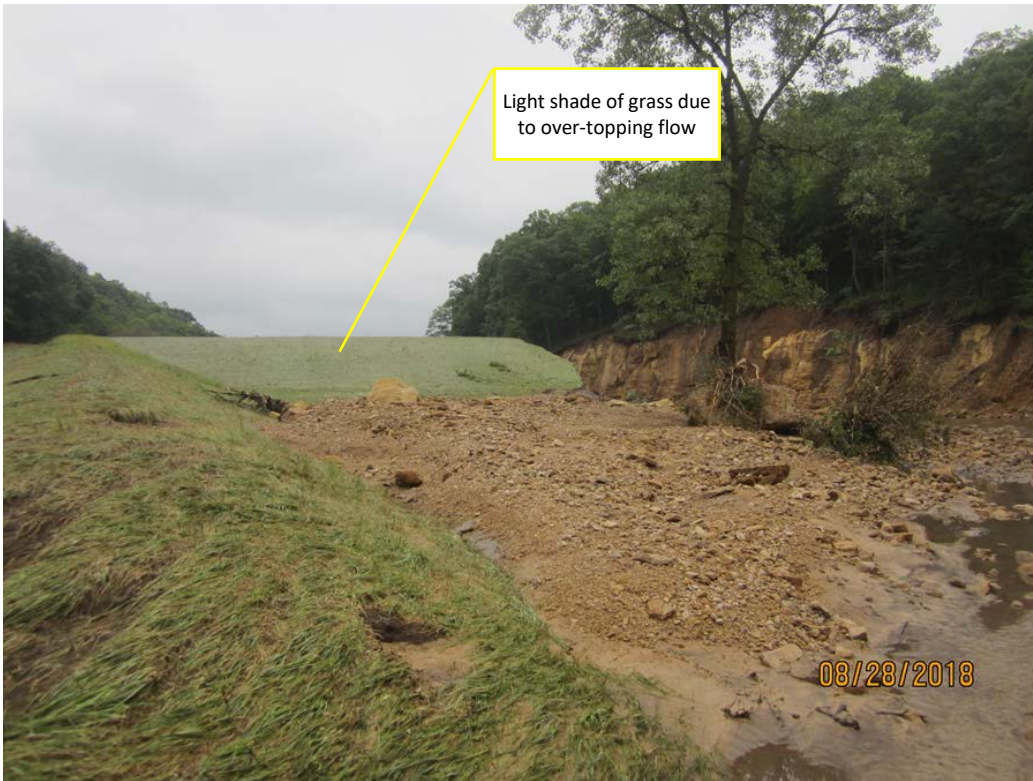
Photo 36

View of dam, auxiliary spillway and debris field from downstream end of auxiliary spillway.
(CC 21)

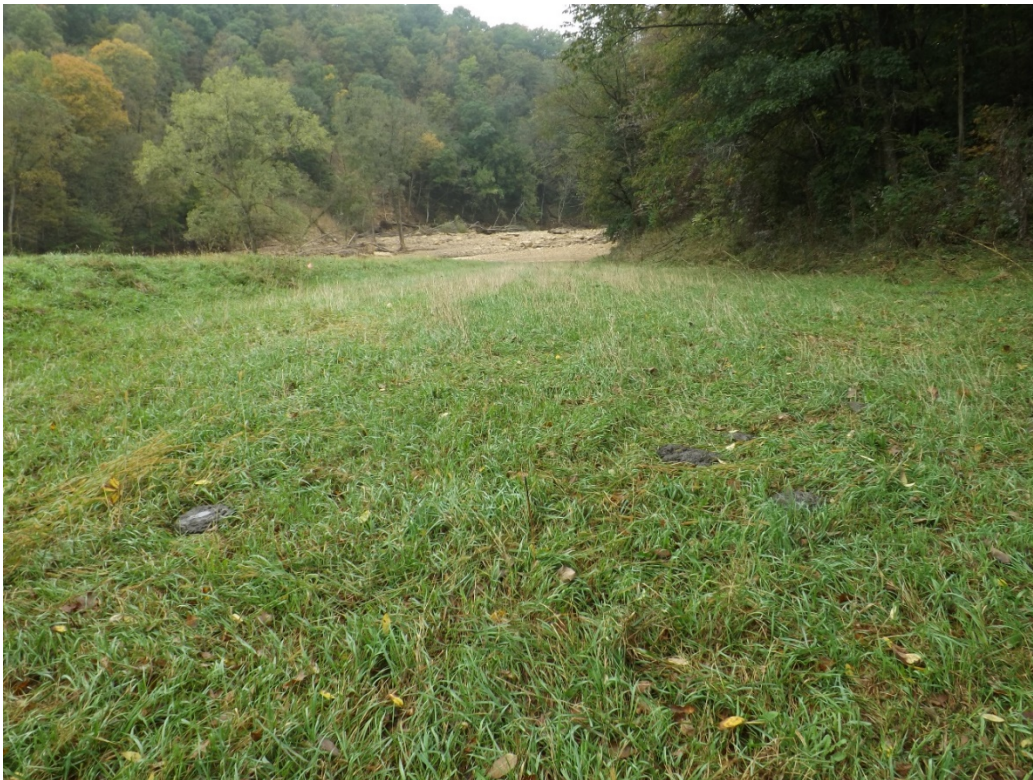
Photo 37

View of auxiliary spillway exit channel from level section
(CC 21)

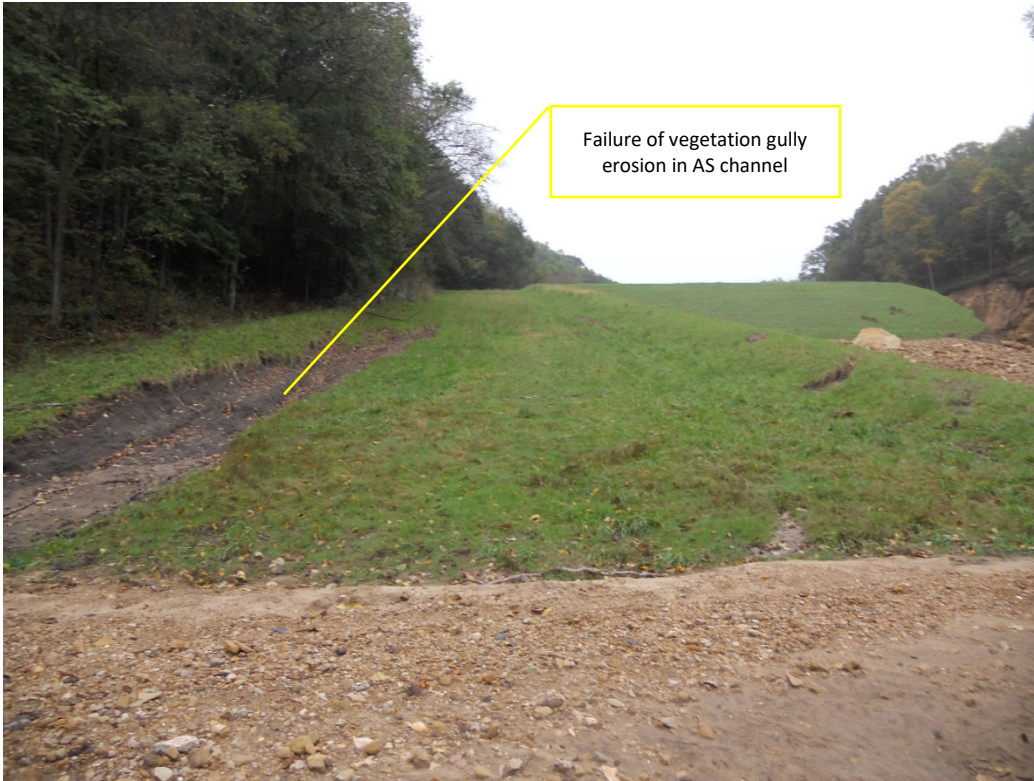
Photo 38

View of auxiliary spillway exit channel from downstream end of auxiliary spillway.
(CC 21)

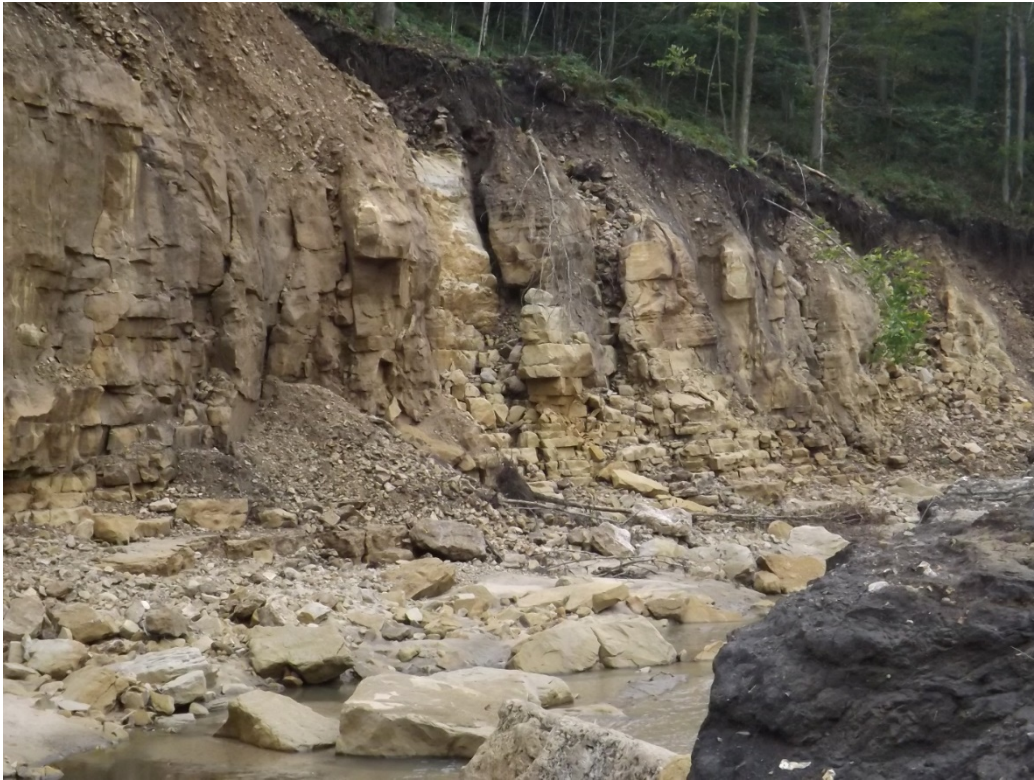
Photo 39

View of exposed bedrock in breach channel from near upstream toe of dam.
(CC 21)

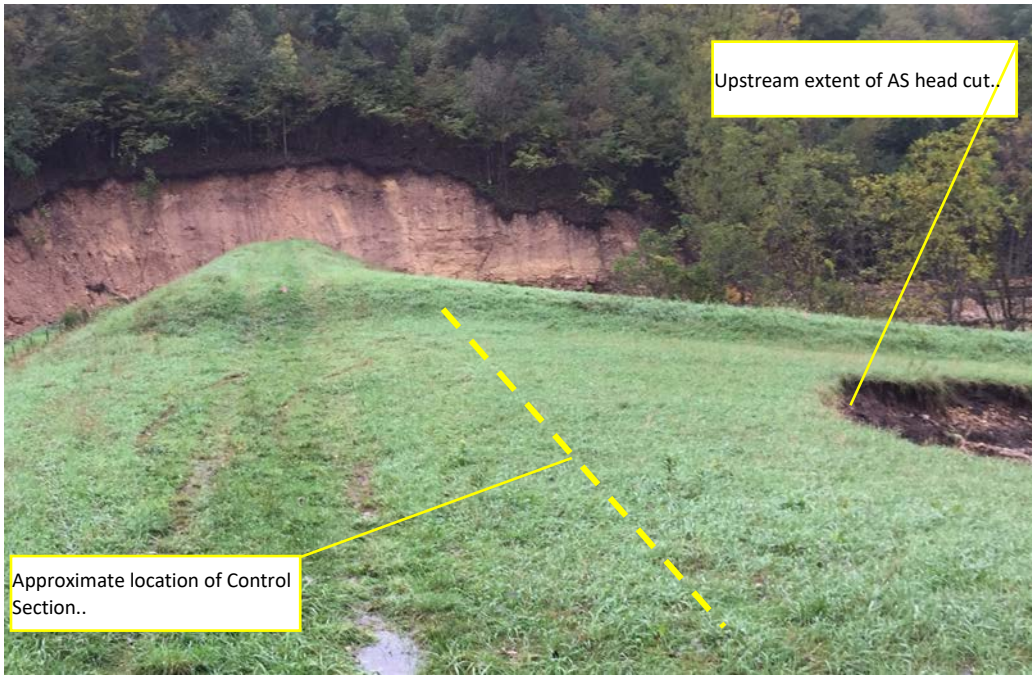
Photo 46

View of upstream end of auxiliary spillway from the right end of top of dam.
(CC 29)

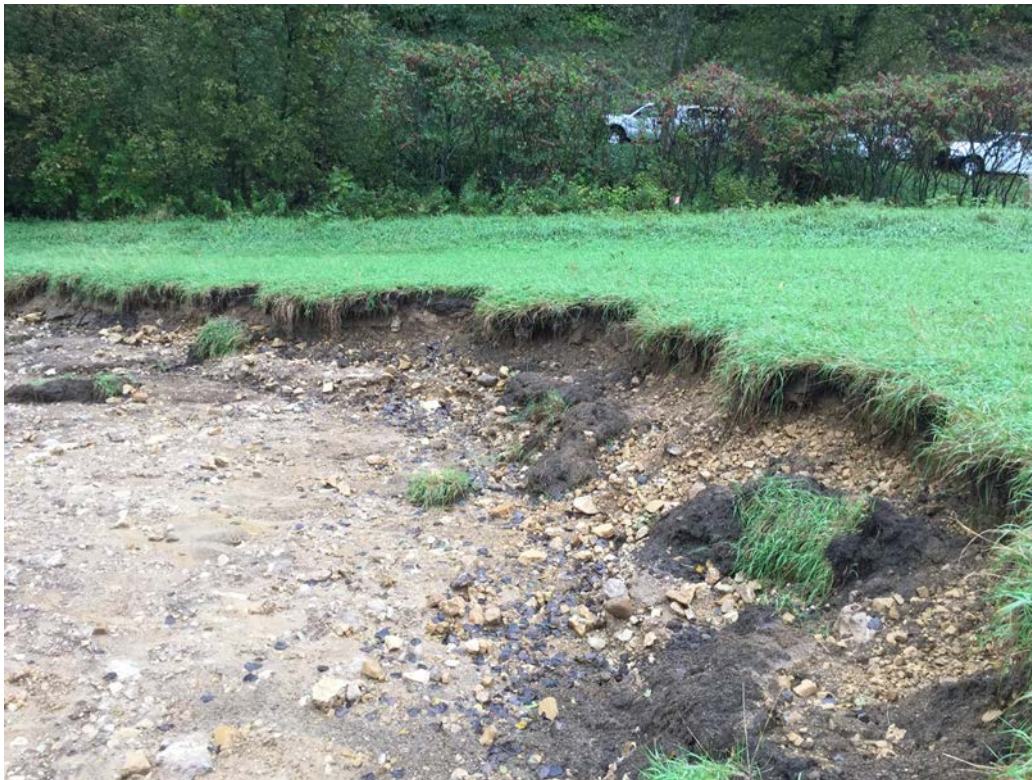
Photo 47

View of auxiliary spillway head cut from left side of channel.
(CC 29)

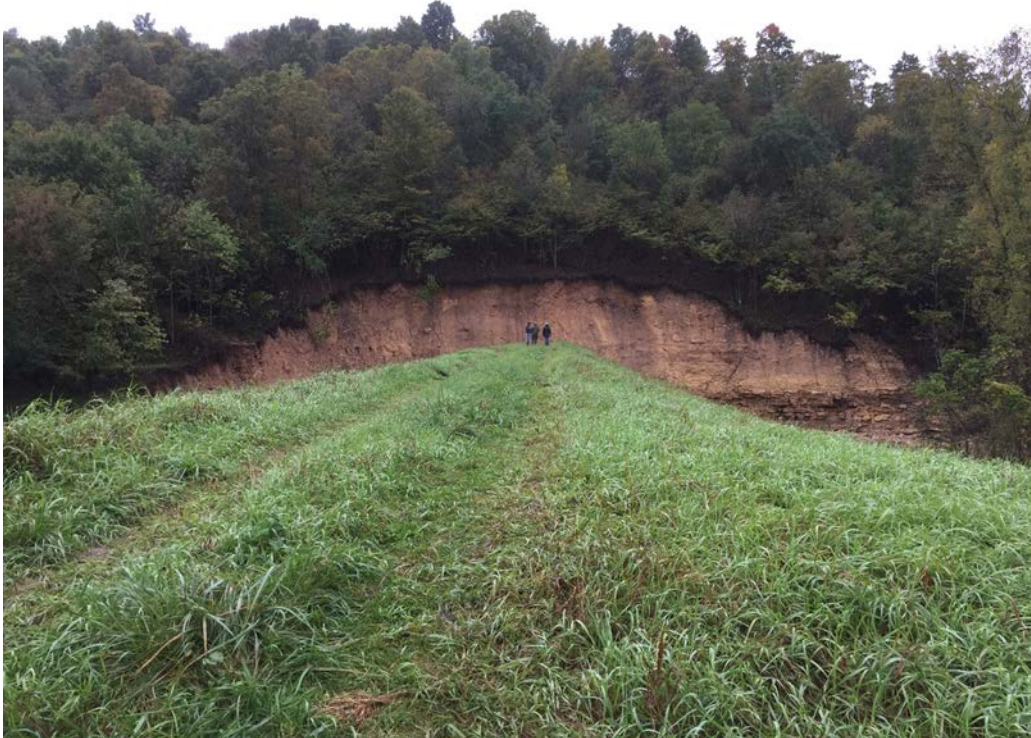
Photo 48

Coon Creek 29 was crowned during construction in similar fashion to CC-21. The crown was more pronounced on this site with a design difference between constructed height and settled height of 2.5 feet. The LiDAR data shows that the crown may have settled some, but was still very pronounced (see Attachment E, CC-29, Sheet 22, Cross Section). The top of dam crown shunted the initial overtopping flows to the embankment ends and down the groins. Only once the ends were overtopped would the higher center of the embankment overtop, just as CC-21. The left end of CC-29 must have breached first, thereby preventing the right side from breaching (see Attachment B, Photos 48 through 52).

View of top of dam and left abutment, post-breach, from right end of dam.
(CC 29)

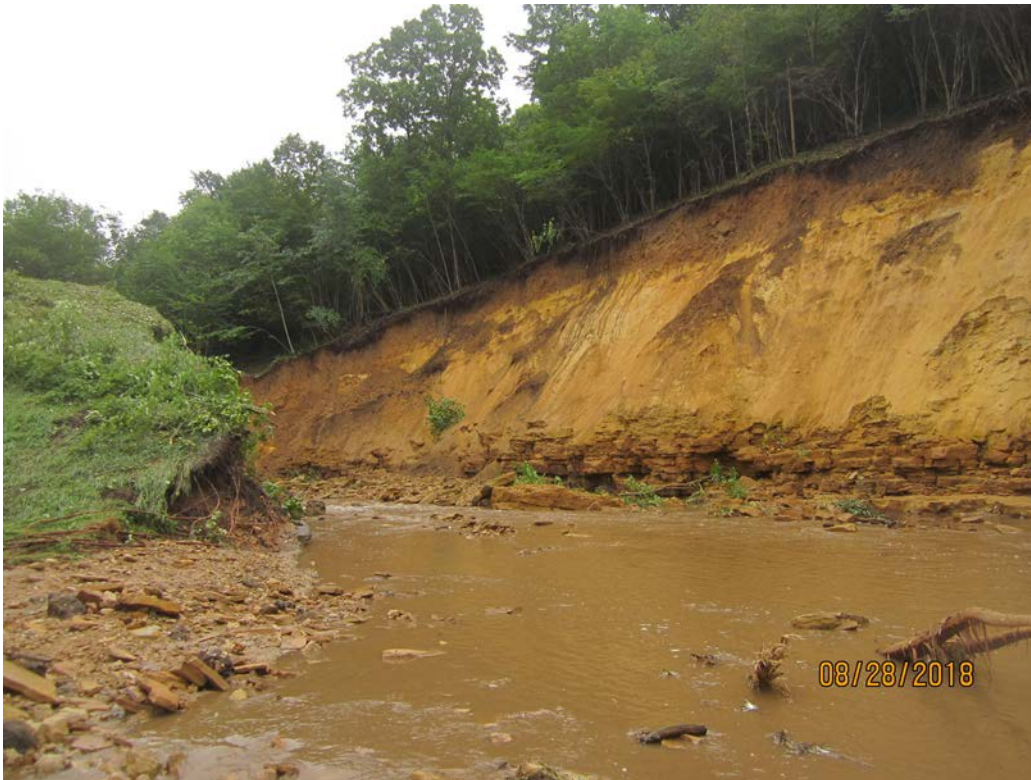
Photo 49

View of breach channel from downstream of the dam. Note photo taken the morning of the event.
(CC 29)

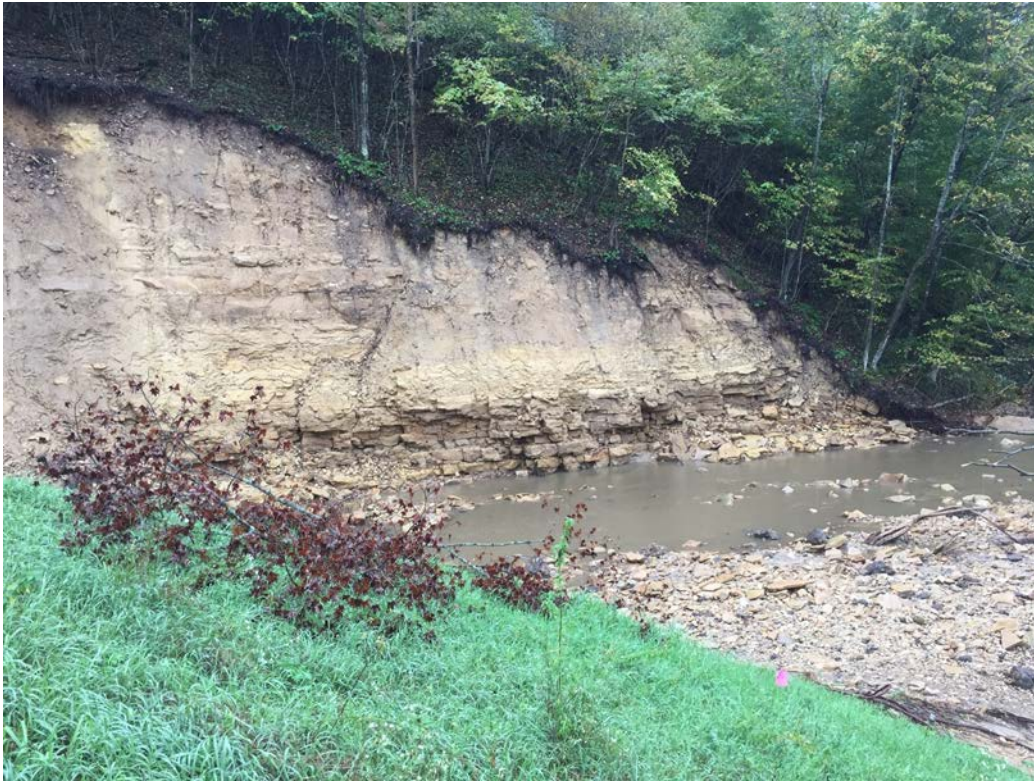
Photo 50

View of jointed and eroded bedrock in left abutment,
downstream end of breach channel, from top of dam.
(CC 29)

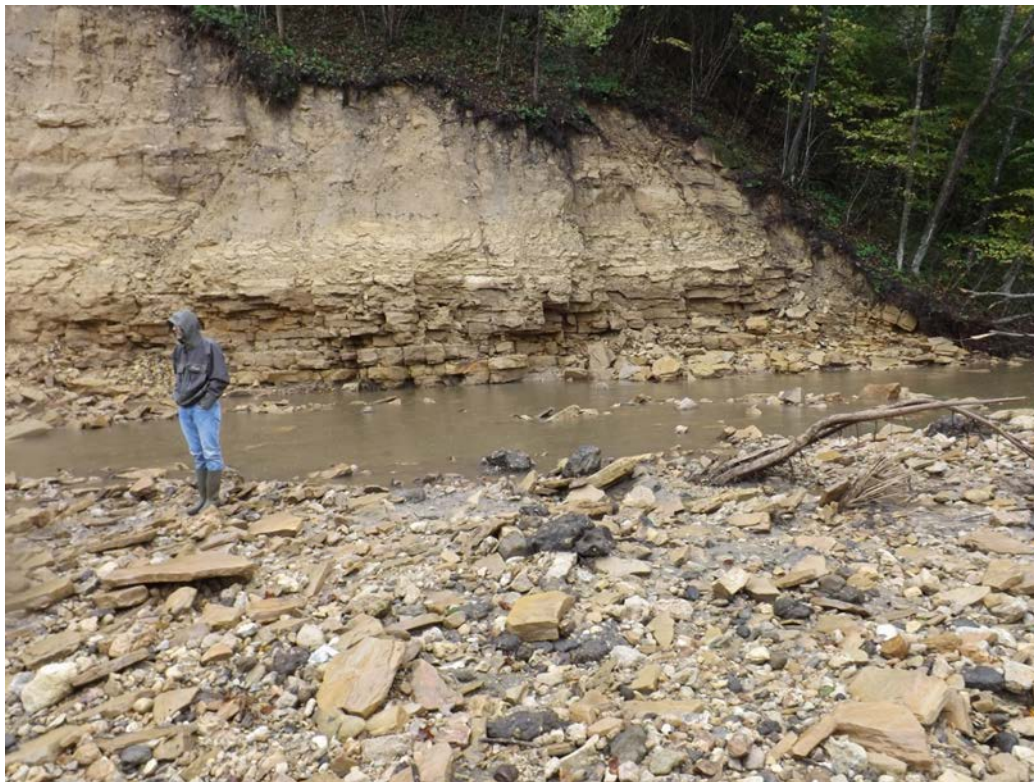
Photo 51

Close up view of left abutment bedrock in outlet end of breach channel.
(CC 29)

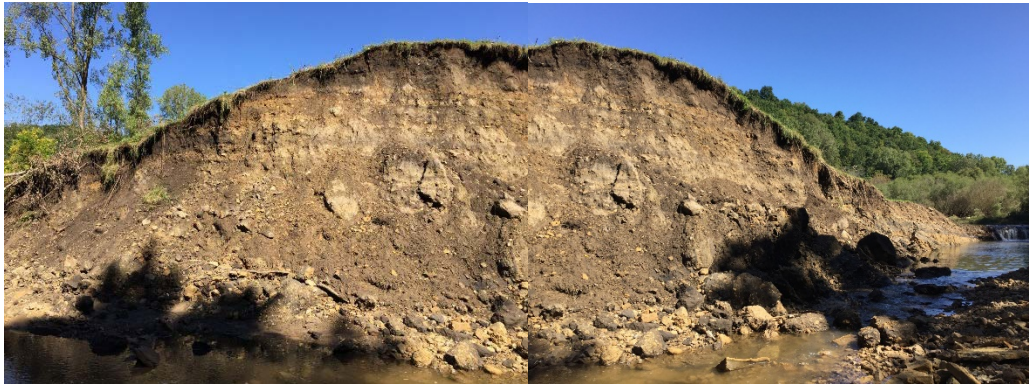
Photo 52

View of exposed end of embankment in breach channel. (CC 29)

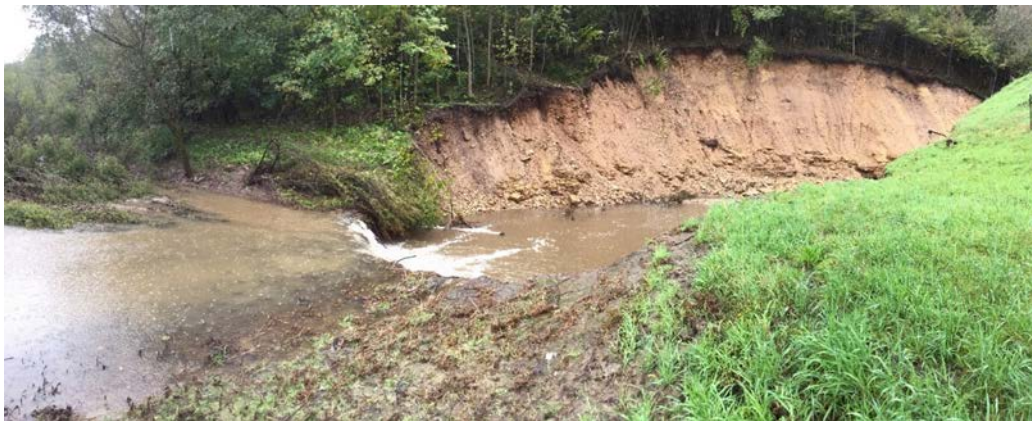
Photo 53

The breach extended below the sediment pool upstream (see Attachment B, Photo 53). The extent of erosion into the abutment was very significant (see Attachment E, CC-29, Sheet 21, Plan View and Sheet 22, Cross Section and Attachment B, Photo 44). The debris field in the breach inundation area of this site was extensive (see Attachment B, Photo 54). A post-breach survey estimated the eroded material volume at 17,000 cubic yards. The failure conditions at CC-29 are similar to those at CC-21. Refer to the narrative on CC-21 and the Geology section for more detail.

View of head cut into sediment pool from upstream toe of dam. (CC 29)

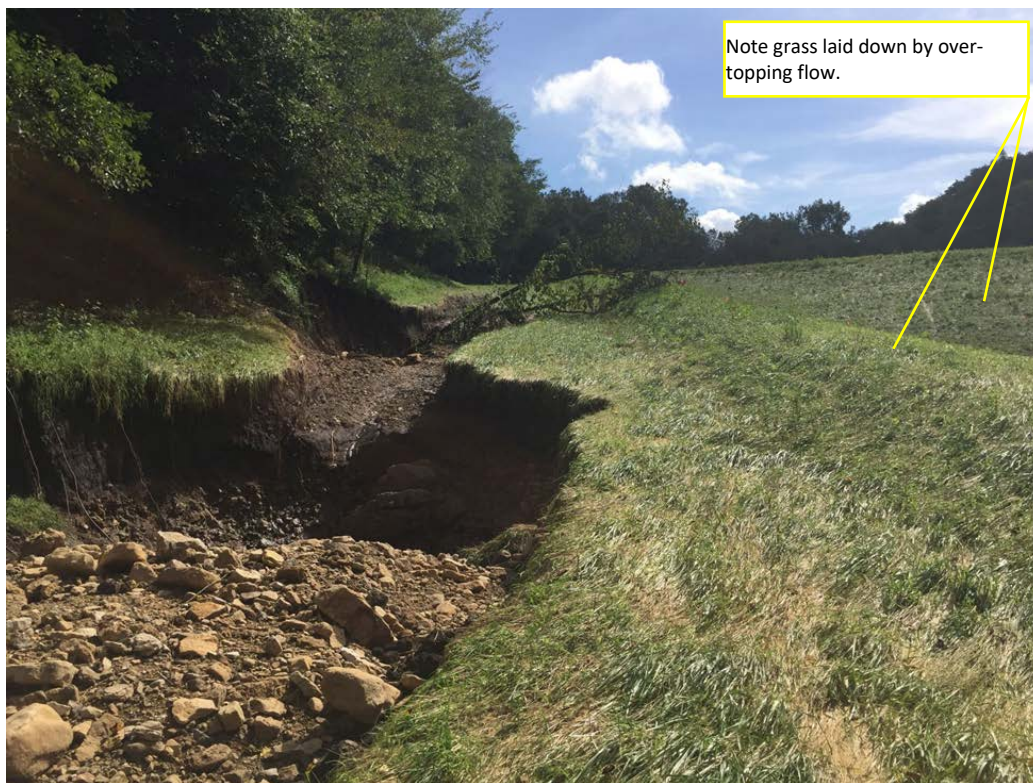
Photo 60

The dam overtopped on this site. The auxiliary spillway, a ramp spillway on the right end of the dam with a 30 ft. wide bottom, did not fail but it sustained significant erosion damage (see Attachment B, Photos 60 through 63). Two large headcuts formed in the lower 2/3 of the spillway. The depth of erosion was well into the bedrock. A smaller headcut, about 18 inches deep, advanced up the exit channel and close to the control section.

View of auxiliary spillway exit channel from downstream end. Note two large headcuts and one small headcut near control section.

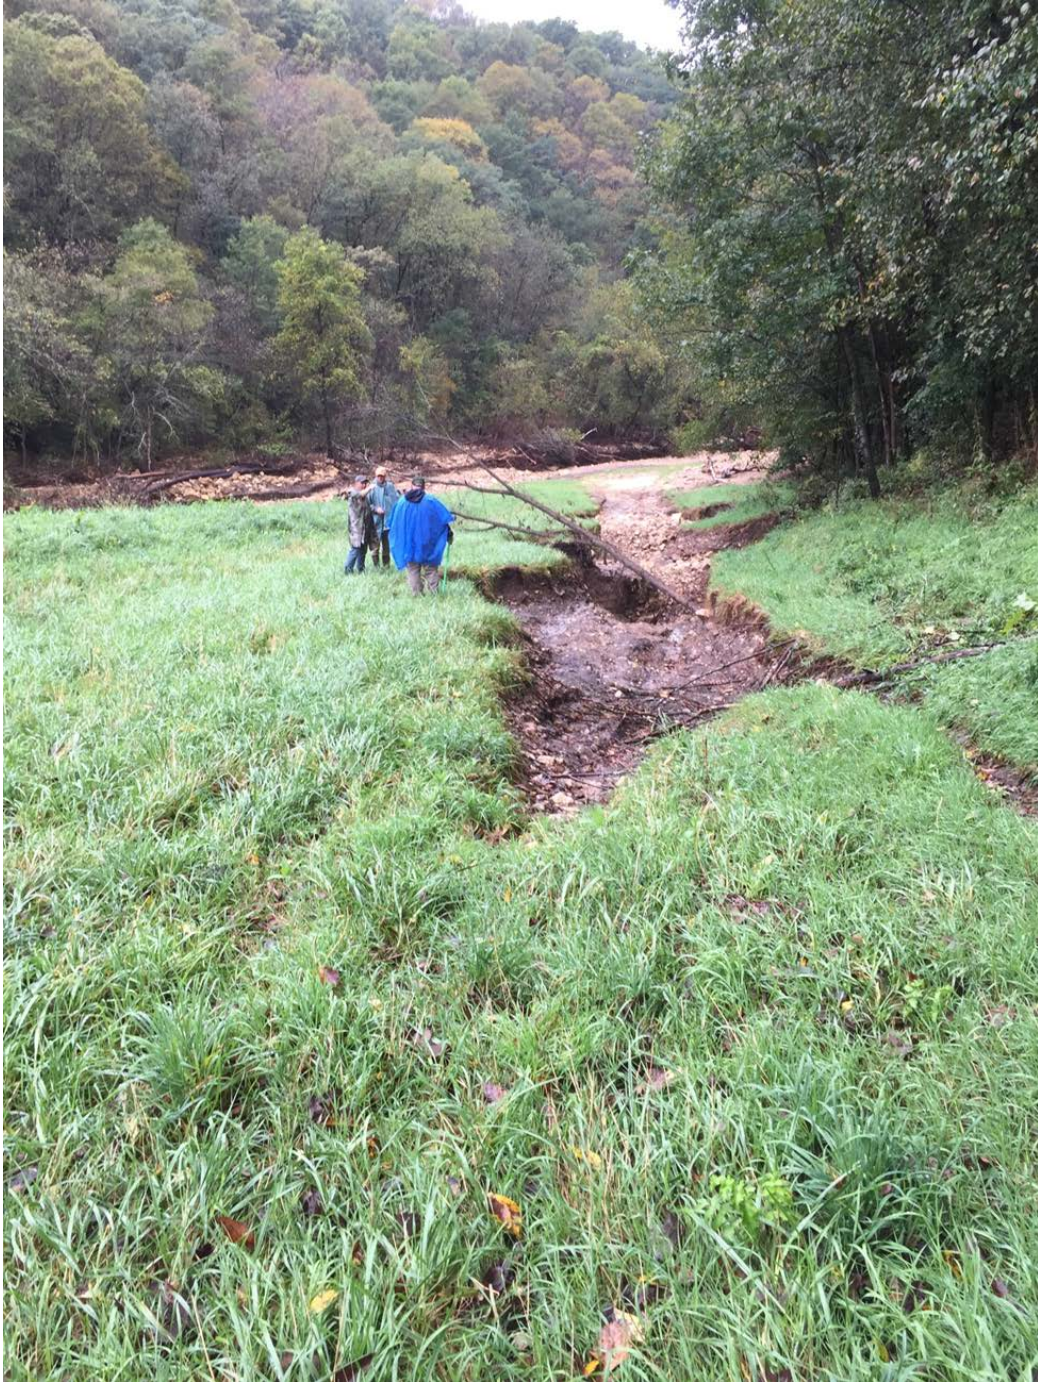
Photo 61

View of auxiliary spillway exit channel from downstream end.
