INVESTIGATION REPORT FOR COON CREEK WATERSHED STRUCTURES 21, 23, AND 29,
AND WEST FORK KICKAPOO WATERSHED STRUCTURES MLSNA AND 1
MONROE AND VERNON COUNTIES, WISCONSIN

U.S. DEPARTMENT OF AGRICULTURE
NATURAL RESOURCES CONSERVATION SERVICE

June 26, 2019

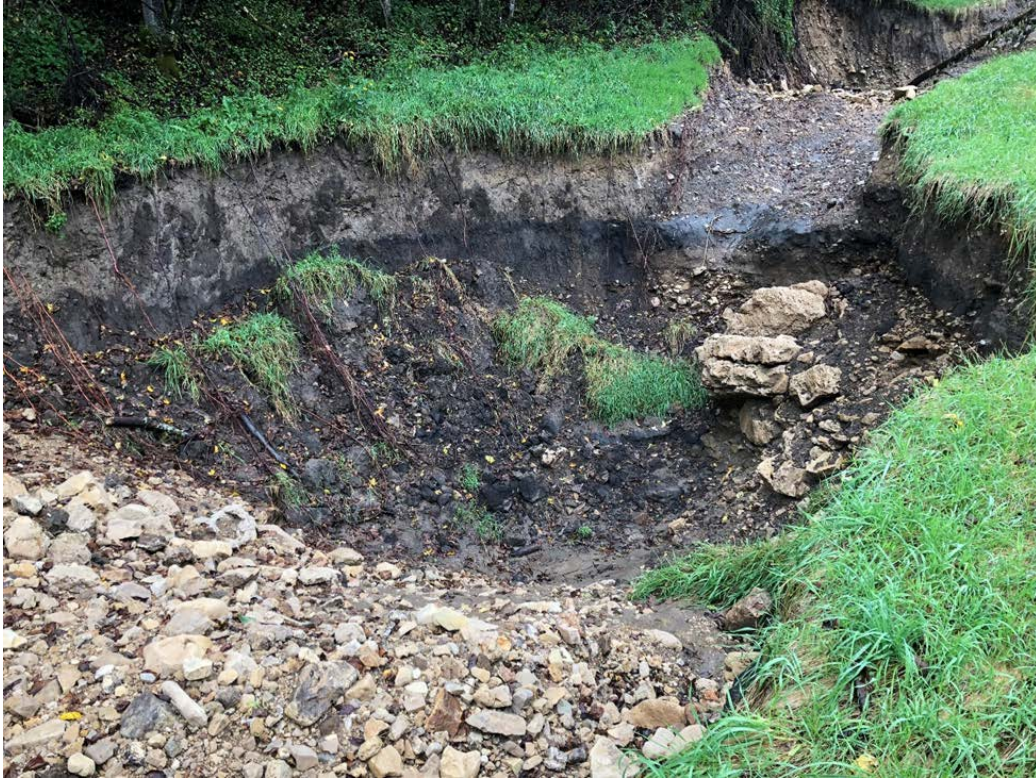
Photo 62

View of auxiliary spillway exit channel from near control section.
(CC 23)

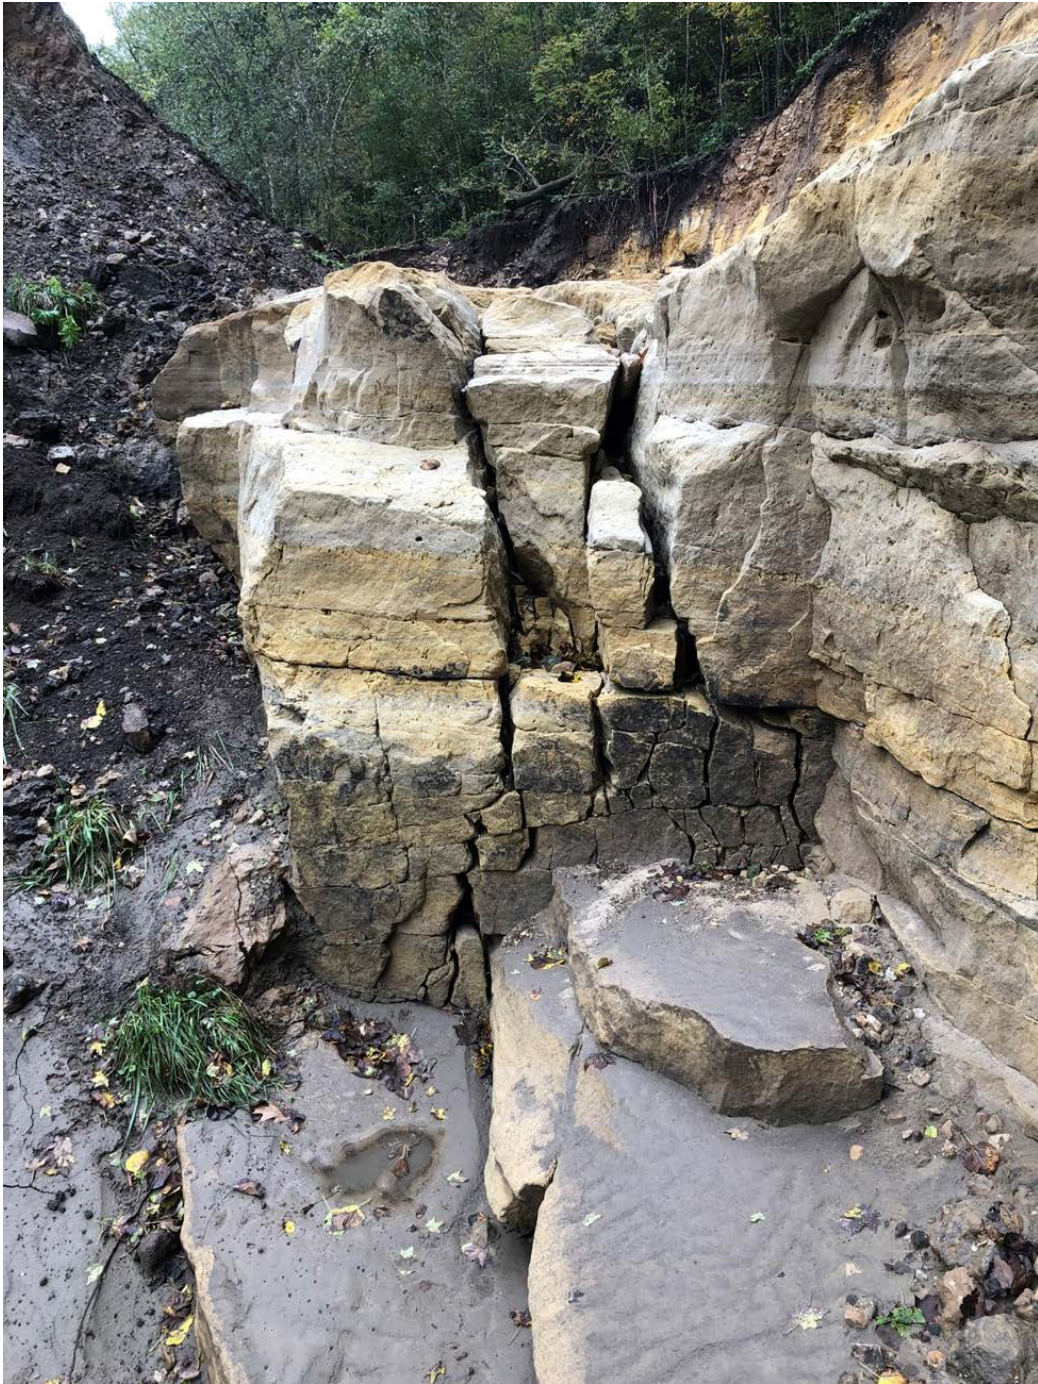
Photo 74
Close up view of vertical valley relief fracture.
(CC 23)

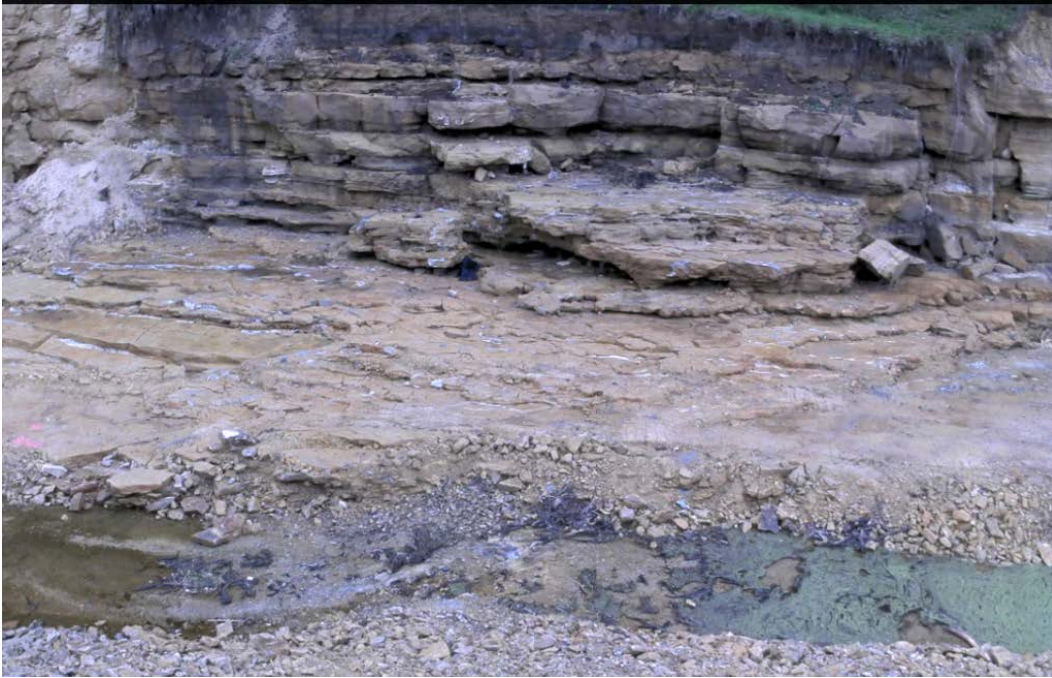
Photo 1
Typical exposure of bedrock in breach channel.
(WFK 1)

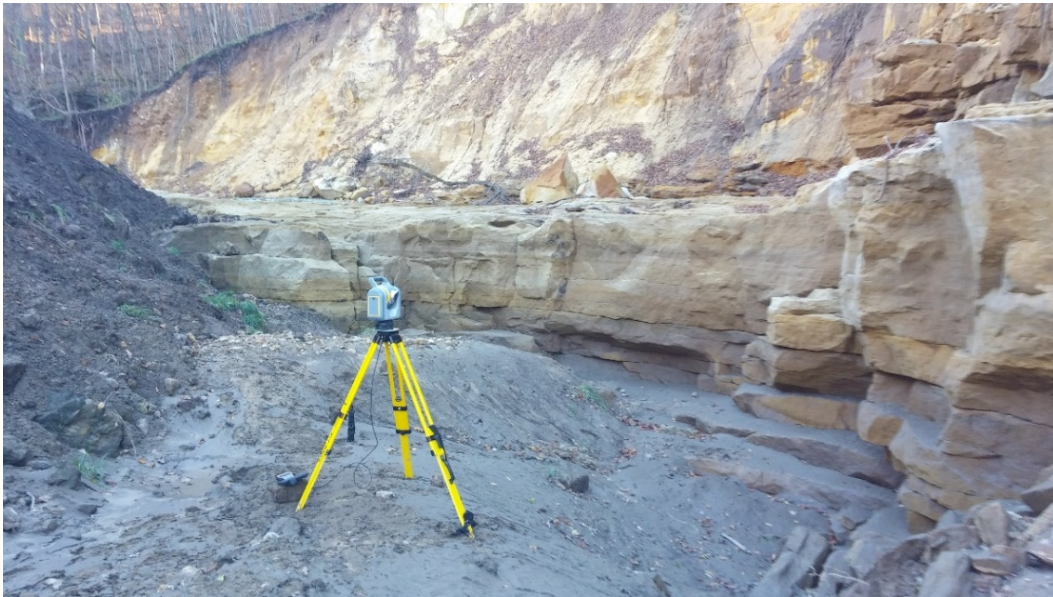
Photo 3

Typical SX10 setup for “fine” 3D scan of exposed abutment bedrock in the breach channel.
(CC 23)
